PREMATURE FAILURES IN PISTONS

## Premature failures in pistons, piston rings, cylinder liners, bearings and bushings

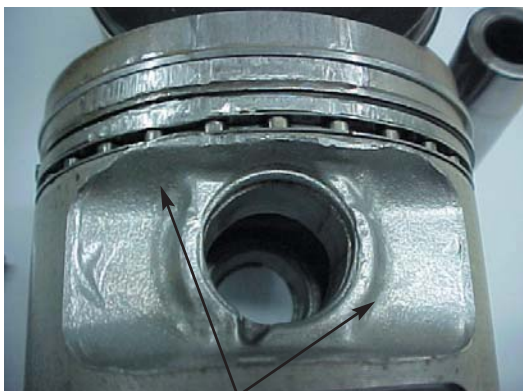
*Fig. 1.1*

- Breakage of the piston pin circlip groove. Generally this occurs due to a composition of forces that pushes the pin against one of the circlips, until its expulsion and/or fracture. Eventually pieces of the fractured circlip cross the inner pin diameter and damage the other end.

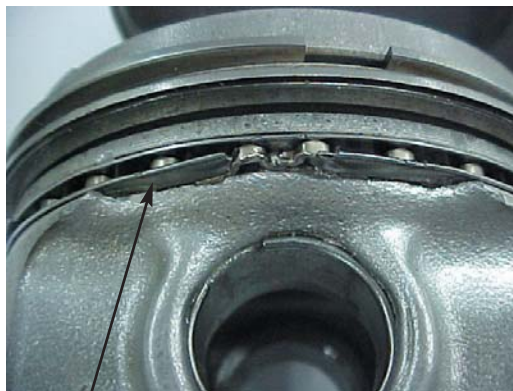
*Fig. 1.1.2 Damages caused by circlip*

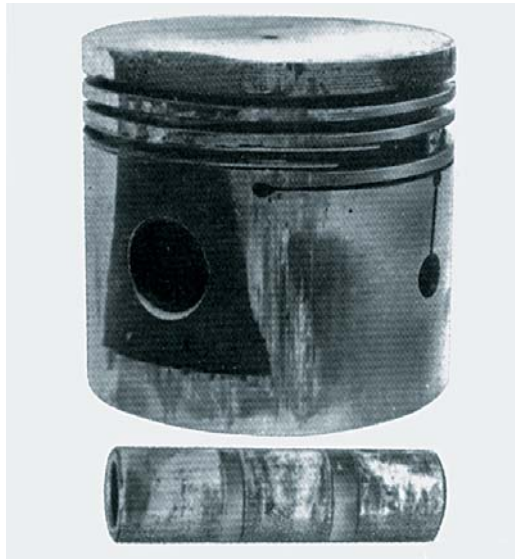
Fig. 1.2

## 1.2 Insufficient clearance between pin and bushing

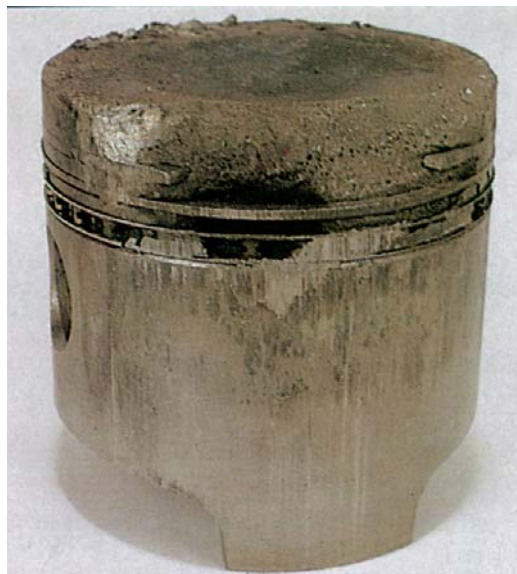
Fig. 2.2

Furthermore, it can originate in its last stages, excessive wear of the first groove, plus breakage, furrows and seizing of the piston rings.

- Use of gears and shifting, inadequate to the vehicle load and speed;
- Cylinders running at too high temperatures;
- Incorrect regulation of the carburetor (extremely poor mixture);
- Excessively advanced spark;
- Low quality fuel (with low octane content);
- Incorrect distributor calibration/regulation;

- Periodical revision of fuel and ignition systems, maintaining them in working conditions as recommended by the engine manufacturer;
- Avoid engine overloading.

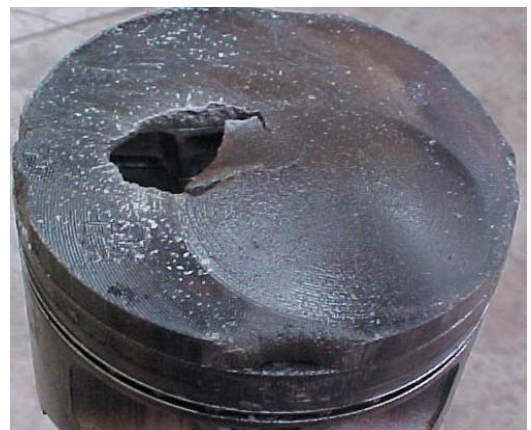
Fig. 2.3.2

- Incorrect spark plugs for the required service;
- Hot spots originated by defective cooling;
- Carbon deposits at very high temperatures (almost incandescent) generating hot spots;
- Valves operating at higher than normal temperatures;
- Detonation or conditions that lead to detonation.

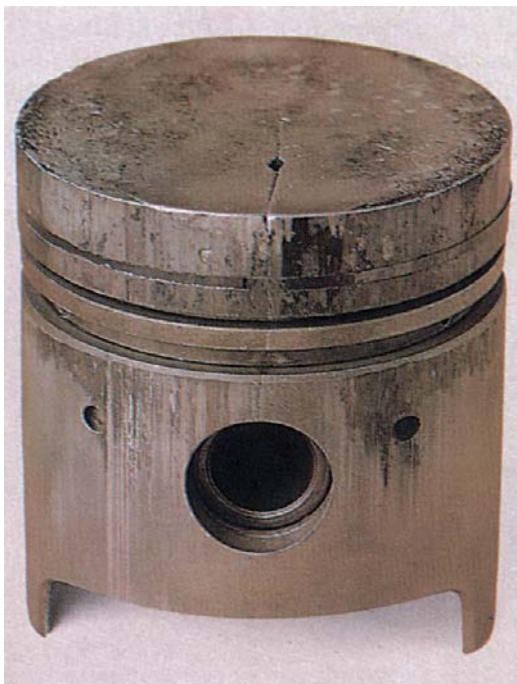
Fig. 2.4

- Cracks on piston crown;

- Cracks on upper part of the pin bosses.

- The cracks formed at the piston crown are a consequence of extreme thermal tensions. Should the cracks have been formed in perpendicular direction to the piston pin axis, in addition to the thermal effects, there have occurred also mechanical stresses, subjecting the piston to traction or compression of the crown's surface;
- If the cracks have been originated at the upper part of the bosses, and from there followed in the direction of the top, tending to part the piston in two, there has been an interaction between the boss and the piston pin. High tensions have occurred, above the recommended values, caused by compression, by deformation of the piston pin and by the wedge effect applied to the surface of the pinhole.

- The engine reconditioning, the regulation of the injection system, as well as de engine running conditions have to be performed according to the specifications given by the engine manufacturer.

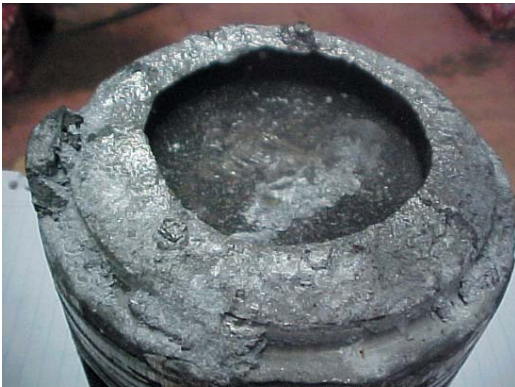
Fig. 2.7

- Excessive fuel injection at each cycle;
- Premature injection (anticipated ignition point);
- Incorrect spraying;
- Leaky injectors nozzle.

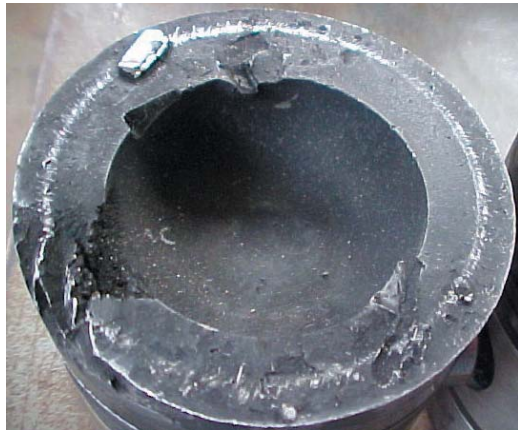
Fig. 2.7.7 Partial destruction of the crown, due to injection defect

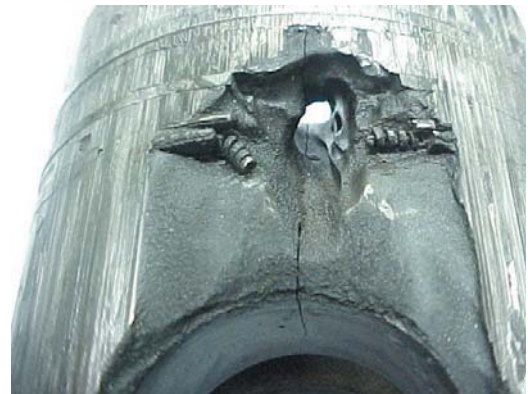
Fig. 2.7.11 Destruction of the crown and the pin boss region, due to irregular function of injection nozzle

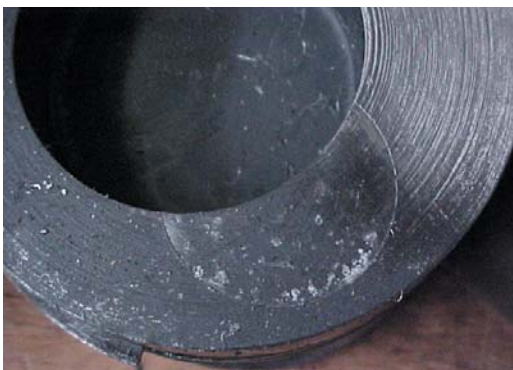
Fig. 2.8.1 Valve mark on machined piston crown

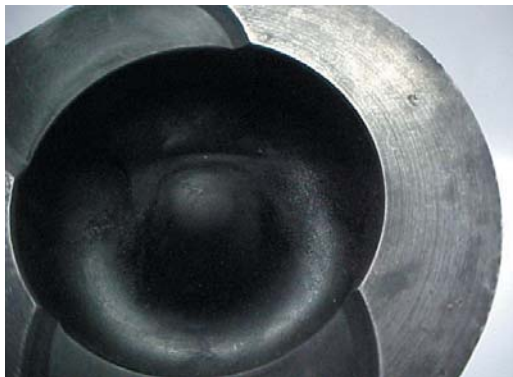
Fig. 2.13.1 Machining marks at piston crown

- Use pistons with lower compression height, if available;
- Replace the engine block.

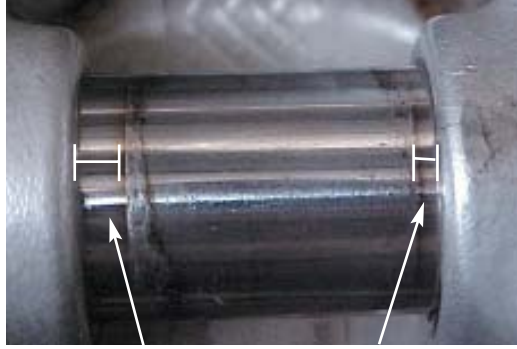
- Incorrect position of the con rod in relation to the piston pin;
- Irregular heating of the con rod during fitting process.

Fig. 2.14 Eccentricity between the con rod and the piston pin

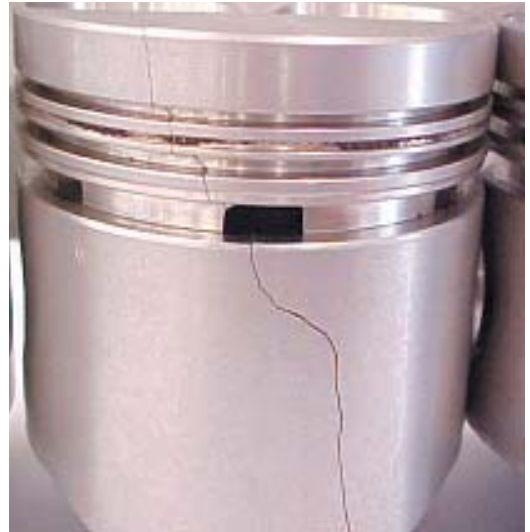
Fig. 2.14.3 Part which has been cracked during con rod fitting

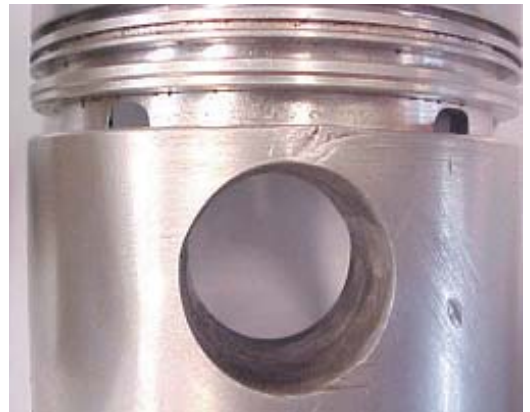
Fig. 2.14.4 Irregular mark, close to the pin boss

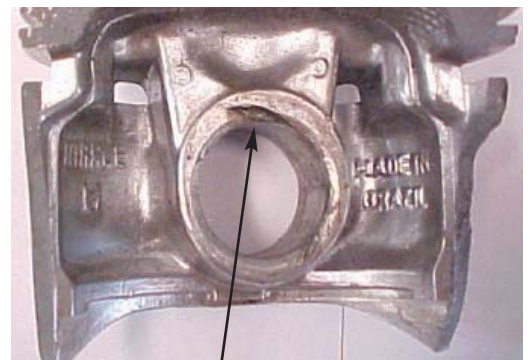
Fig. 2.14.5 Piston pin mark on the pin boss

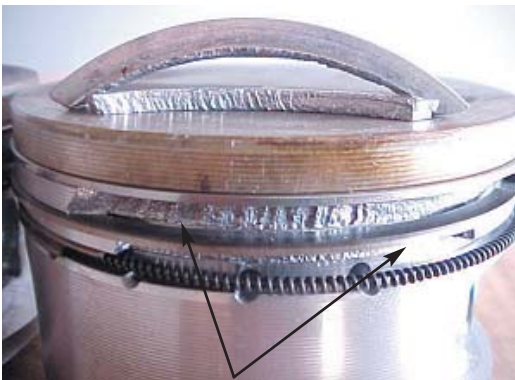
a consequence of a sudden combustion pressure peak. This occurs due to the an increase in admitted fuel volume/mass, due to the decrease in combustion chamber volume in the cylinder head and also due to an incorrect injection/ignition point. Under these conditions the piston is submitted to an increase in mechanical and thermal loads (higher peak pressure), causing the rupture of the lands between the ring grooves. This rupture/ breakage is related to the process called "DETONATION".

Fig. 2.15 Broken lands in piston (Otto-cycle engine)

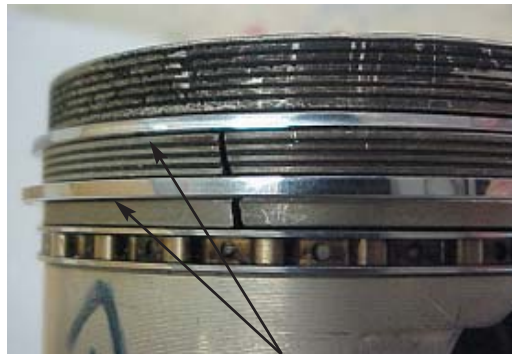
Fig. 2.15.2 Fractured lands in piston (Otto-cycle engine)

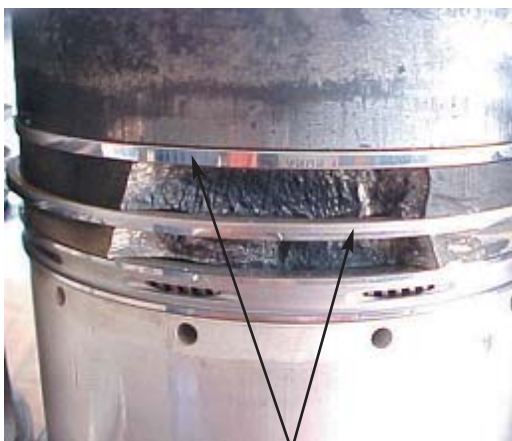
Fig. 2.15.4 Fractured lands in piston (Diesel-cycle engine)

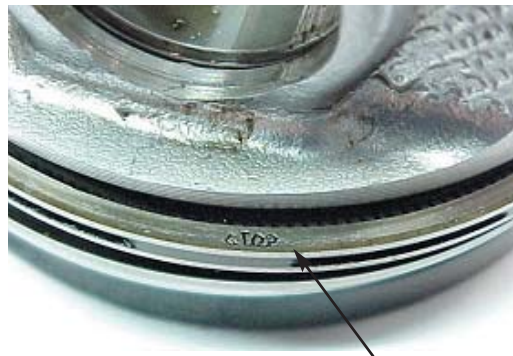
Fig. 3.1 Piston ring mark mounted towards the lower side

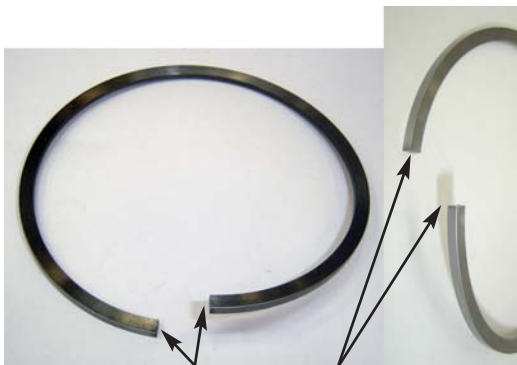
Fig. 3.4 Displaced butts due to incorrect mounting

The recommended gap opening, during the piston ring installation, shall not exceed 8,3 times the radial width of the piston ring. For example: a piston ring with radial width of 3,00 mm has a maximum gap opening allowance of  $3,00 \times 8,3 = 24,90$  mm.

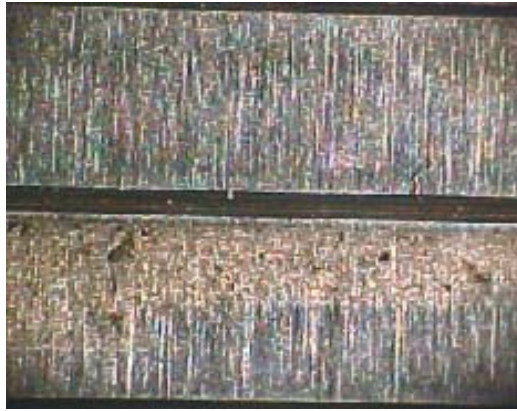
Fig. 3.5.1 Piston rings with scratches on running face

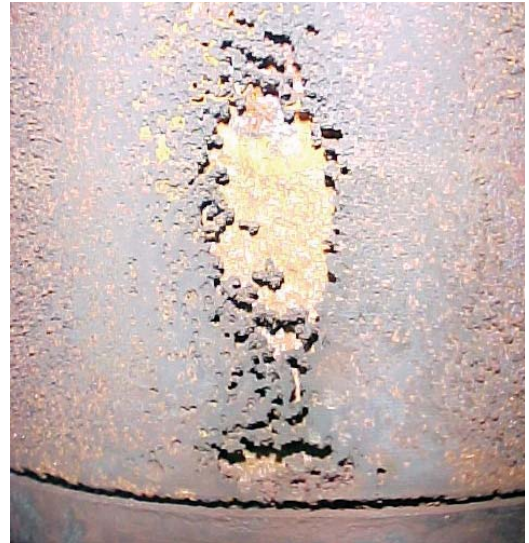
Fig. 6.1.3 Cavitation without corrosion

- Keep all cooling system components (reservoir and/or radiator cap, hoses and clamps, thermostatic and pressostatic valves, water pump, etc.) in normal running conditions, compatible with the engine project;
- Always use the corrosion inhibitor additives and the anti-freezing fluids, as recommended by the manufacturer/producer of the engine;
- Keep the correct water level in the reservoir and/or radiator. When there is a refilling need in the water system, follow the recommendations given by the engine manufacturer, with regard to quantity of additives to be used;
- Assemble the engine according to recommendations given by the manufacturer/producer with regard to eventual changes in pistons, injection system or any other.

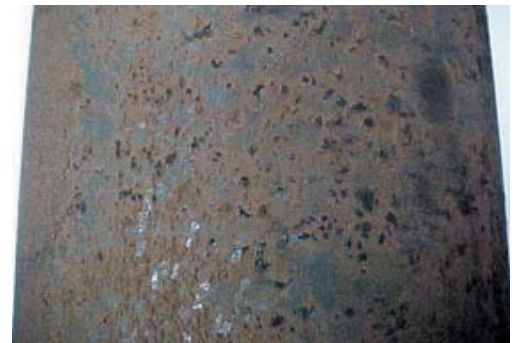
Fig. 6.1.4 Scales

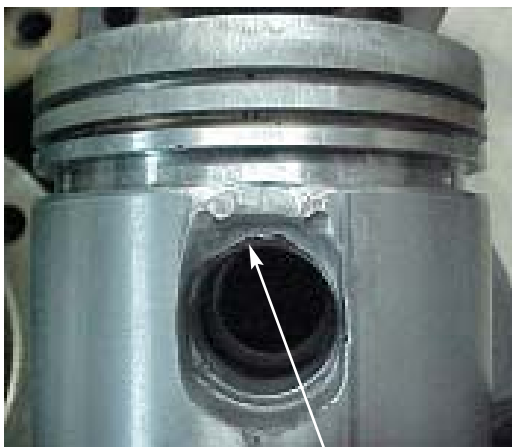
These factors cause misalignment and generate lateral forces, by which the con rod "pushes" the piston pin against the circlip. Once the circlip is expelled, the piston ring will start to move until it touches the cylinder liner. The expelled circlip, due to the vertical up-and-down piston movements, will wear the region (aluminum) until it manages to get free.

Fig. 6.2 Piston wear, at the bosses and crown region, caused by the circlip

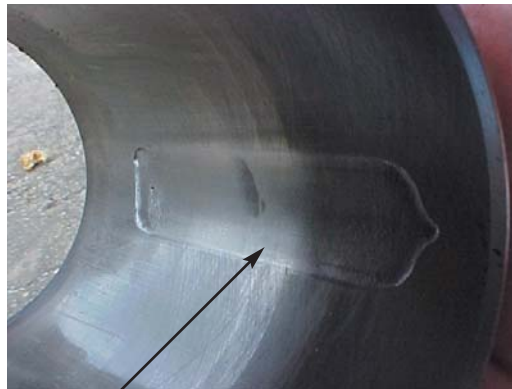
Fig. 6.2.1 Mark originated by the piston pin displacement after the circlip expulsion

- Keep the parallelism between the bushing housing center and the con rod bearing housing center;
- Fit the con rod according to recommendations given by the engine manufacturer;
- Install and locate correctly the circlip in its housing;
- Grinding the crankshaft and keep the journal according to the patterns recommended by the engine manufacturer.

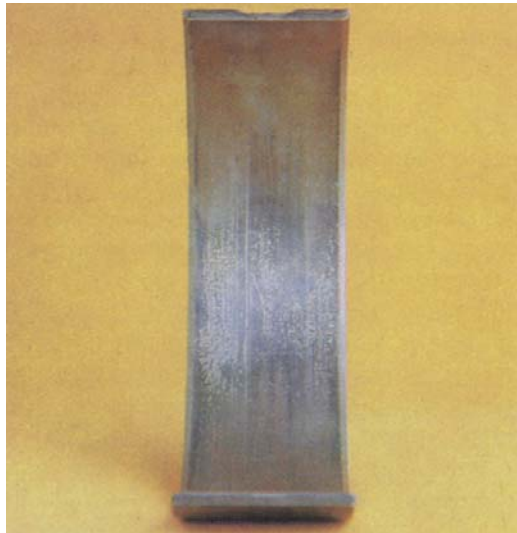
Fig. 7.1

the bearings to air and water, and to other materials, which might exist in the oil, including certain metals that can produce catalytic effects. Other contributing factors include the passage of gases to the carter (blow-by) and the combustion of fuels with high sulphur content, plus the possibility of inorganic acid formation.

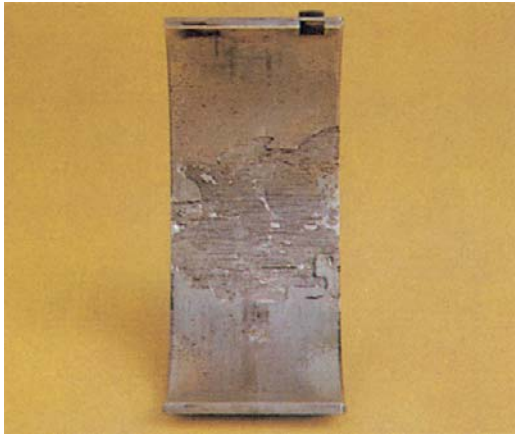
Fig. 7.3

- The bearing surface presents irregular areas with detached anti-friction material.

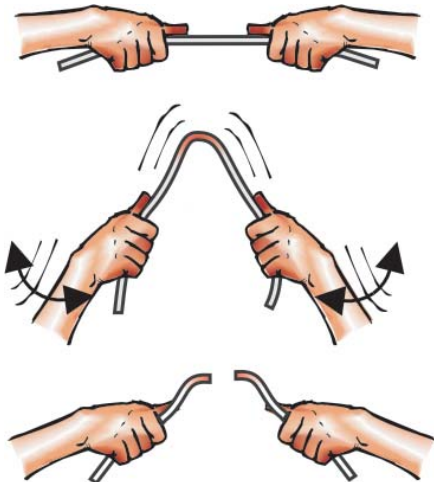
These fractures can get united to each other, which will result in bearing material detachment. One of the most common types of fatigue occurs at the upper layer of tri-metallic bearings, where the fractures, after perpendicular penetration, propagate in parallel to the nickel barrier, causing its removal in reduced areas (fig. 7.3.2).

Fig. 7.3.1 Fatigue

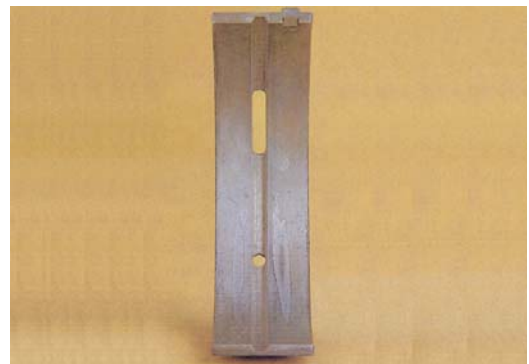
Fig. 7.5

- Some regions of the bearing surface are eroded. In some cases the erosion can cross the whole material depth of the bearing alloy and reach the steel shell.

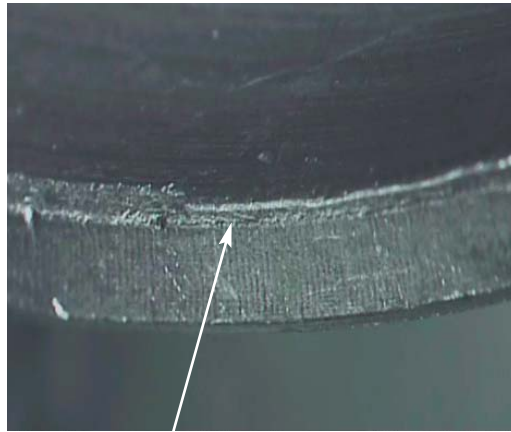
dynamic support to the axle. This results in a contact between the axle and the bearing surface, causing fusion and surface deformation of the bearing's anti-friction alloy (figs. 7.6 to 7.6.3).

Fig. 7.6 Yield of material

- Check the diametrical dimensions of bearings, con rods and crankshaft throws;
- Apply always the correct torque to the bolts and substitute them whenever recommended by the manufacturer/producer;
- Use adequate lubricating oil in your engine, as recommended by the manufacturer/producer.

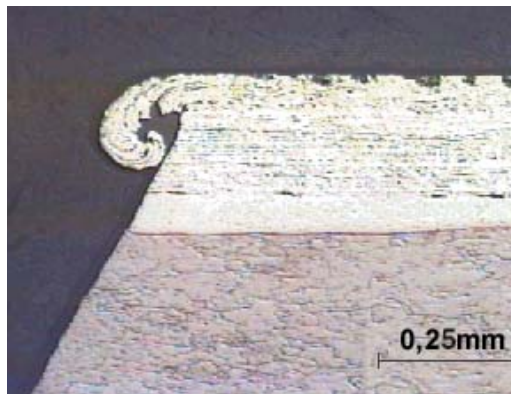
Fig. 7.6.1 Yield of material (enlarged photo)

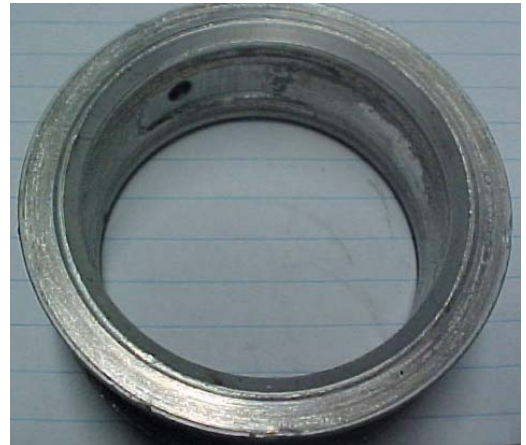
Fig. 8.1.2 Totally worn-out flange

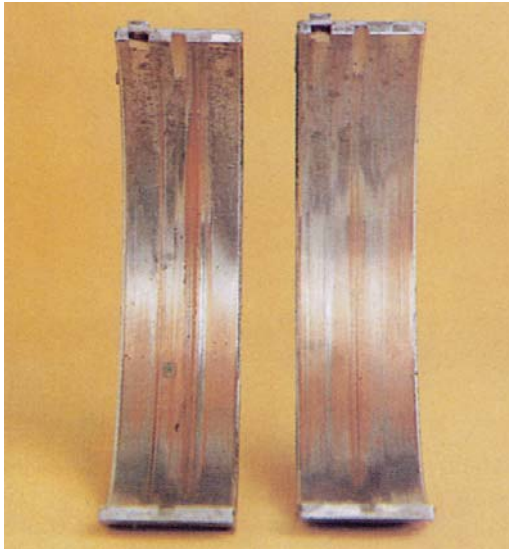
Fig. 8.2

- Foreign particles get imbued in the anti-friction alloy, resulting in material displacement. Scratches on the bearing surface can also be found.

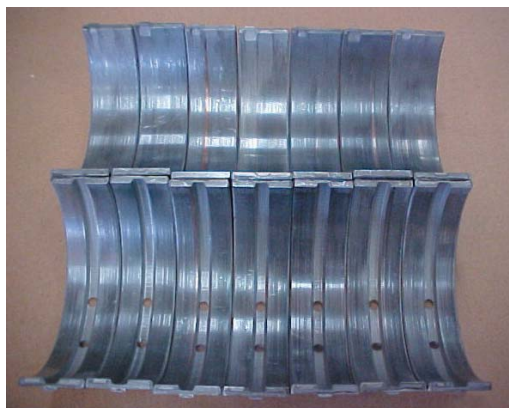
Fig. 8.2.4 Contaminated main bearings with circumferential scratches

- Install new bearings, following carefully the recommended cleaning instructions;
- Grinding the axle, if necessary;
- Recommend the operator to change periodically the oil and its filter, at the intervals specified by the engine manufacturer. Keep the air filter and the breather crankcase clean.

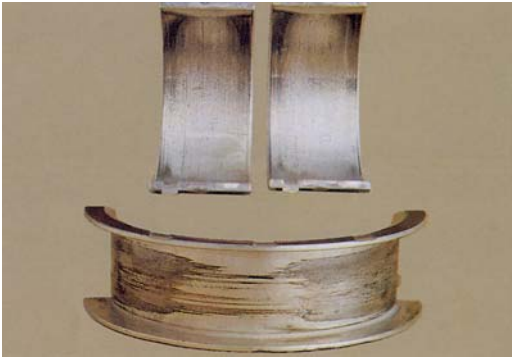
Fig. 8.4

- Areas with excessive wear close to the bearing partition line.

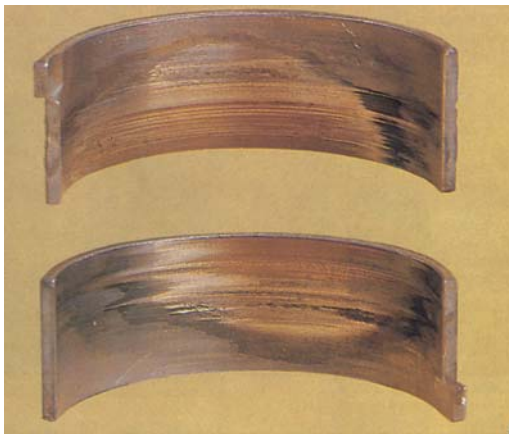
Fig. 8.7

- Excessively worn-out areas on diagonally opposed sides of each bearing.

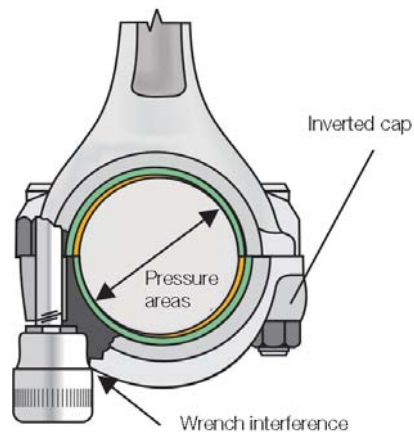
Fig. 8.8 Displaced cap

- Choose adequate wrench and fasten bolts alternatively in order to get a perfect cap seating;
- Be sure the cap position is correct;
- Check if the cap centralizing system is not altered nor damaged, and replace it, if necessary;
- Replace the con rod and/or housing bolts according to the recommendations given by the engine manufacturer;
- Machine the crankshaft according to specifications given by the engine manufacturer.

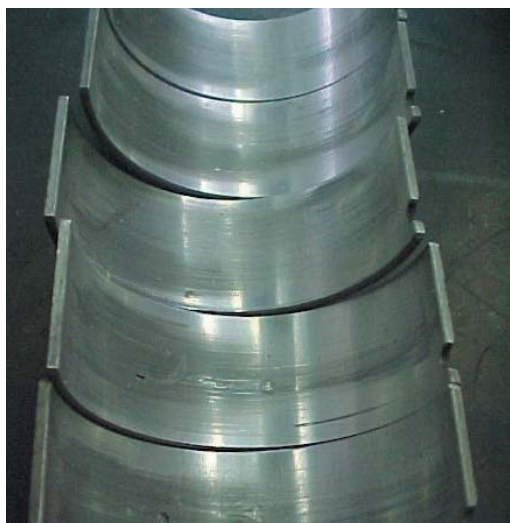
Fig. 8.8.2 Premature wear

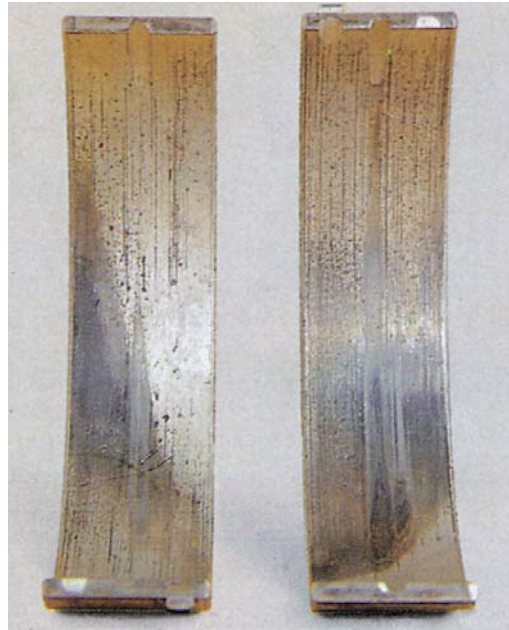
Fig. 8.10

- A well-defined wear strip can be observed at the upper or at the under main bearing set. The extension of this wear can change from bearing to bearing, but in general it is more accentuated at the center bearing.

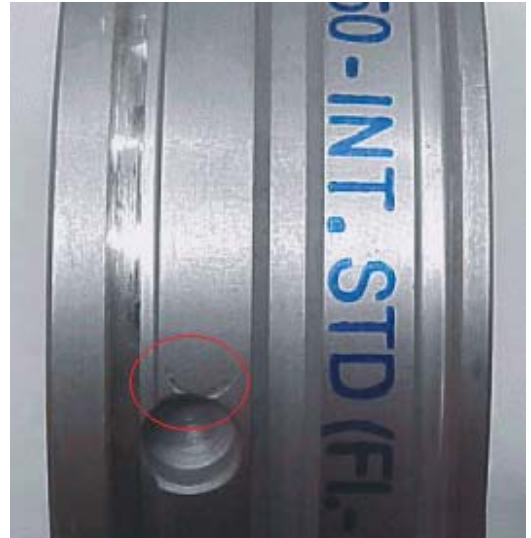
Fig. 8.13.1 Pin mark on external bearing side

- Check/revise the wrench periodically;
- Apply the torque recommended by the engine manufacturer;
- Assemble the engine according to recommendations given by the engine manufacturer, specifically with regard to the use or no-use of glue/adhesive.

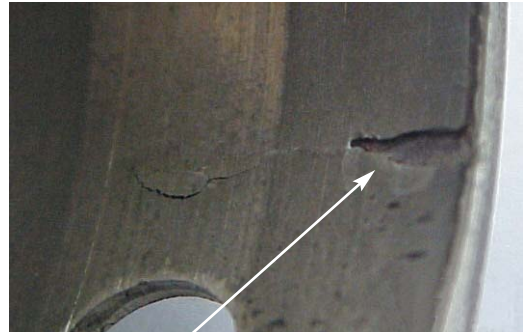
Fig. 10.2.3 Alloy detachment

- Check the housing circularity before mounting a new bushing;
- In the case of a highly deformed housing, rectify it and use bushings with external oversize;
- Keep the clearance and interference specifications between the bushing and the housing, as recommended by the engine manufacturer.

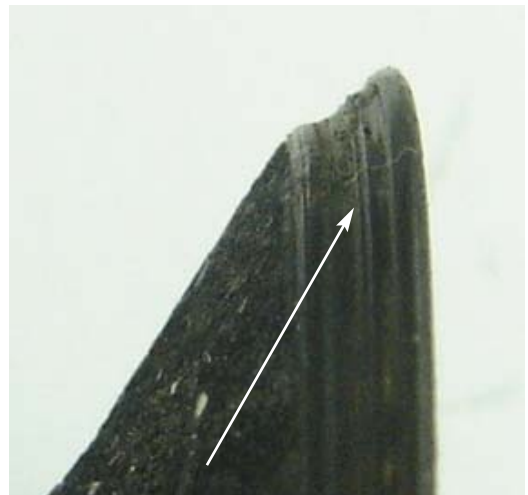
Fig. 11.2.1 Wear in the seat region

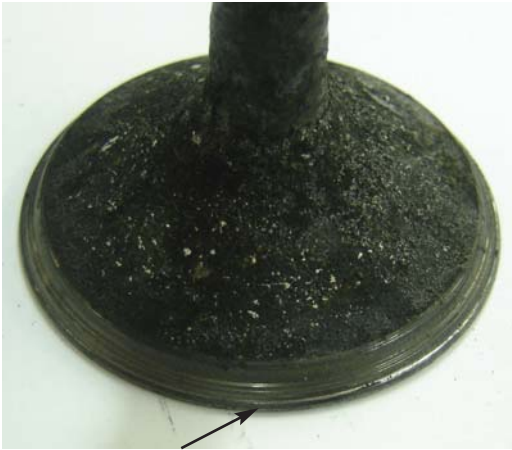
Fig. 11.2.2 Wear in the seat region

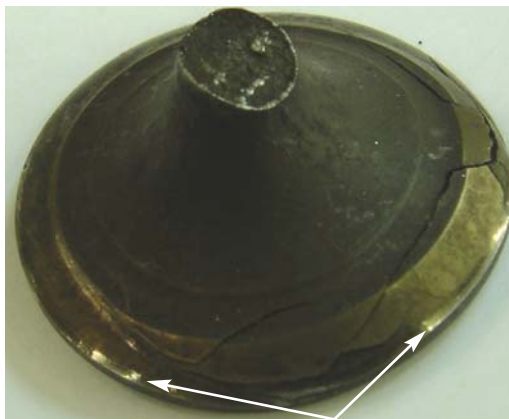
Fig. 11.3.2 Broken valve head at the radius and stem region

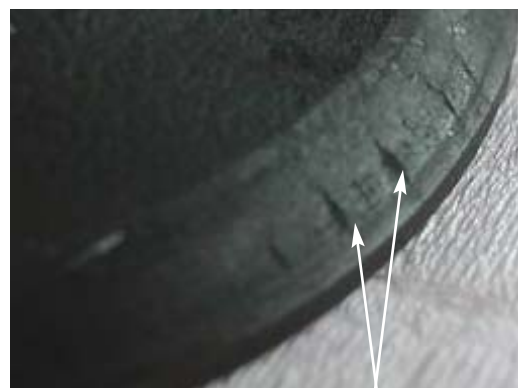
Fig. 11.5.2 Fissures on the valve seat

- Correct the alignment of valve steam and valve seat, seat sealing (valve and valve seat) as well as operate the vehicle according to the manufacturer's recommendations.

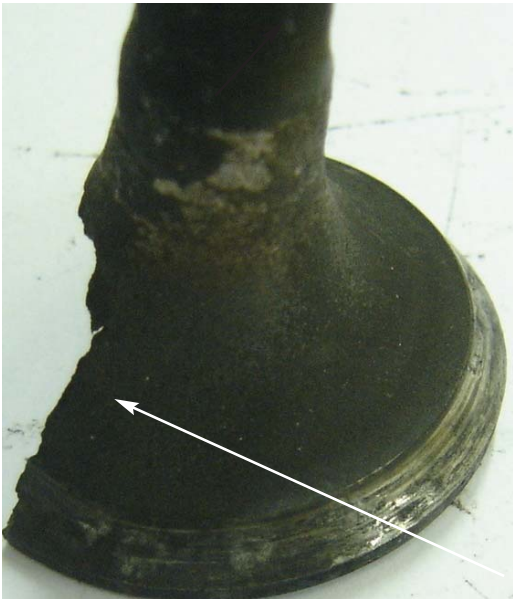
Fig. 11.6.2 Breakage of part of the head

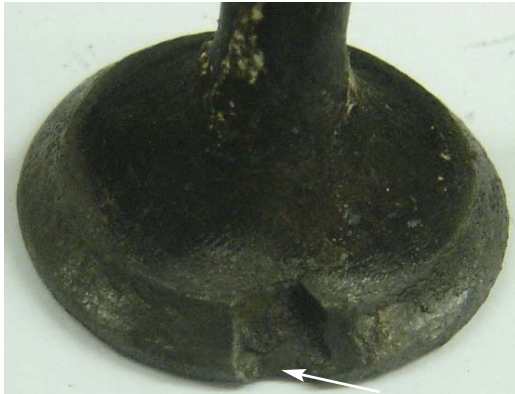
Fig. 11.8.1 Localized disintegration at the seat region

- Provide the correct seating, as well as keep the air/fuel mixture as homogeneous, and clean the cylinder head cooling galleries with products recommended by the engine manufacturer. Avoid long working cycles under idle condition.

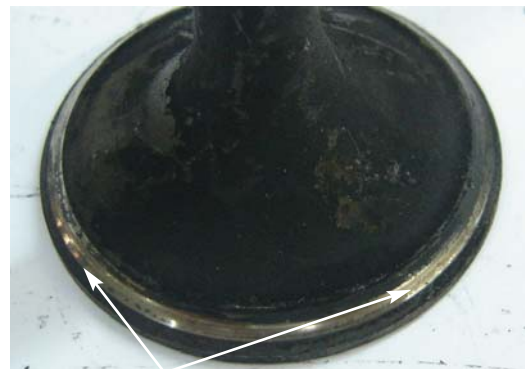
Fig. 11.9.1 Irregular seating area

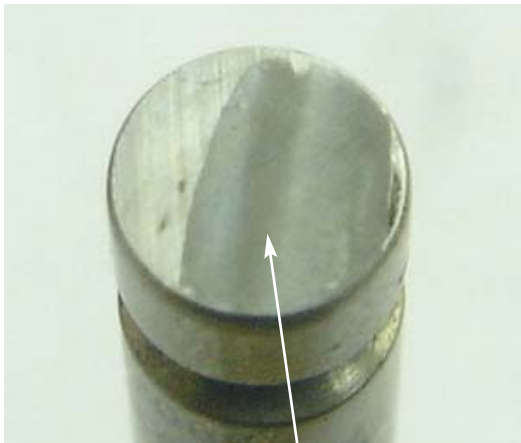
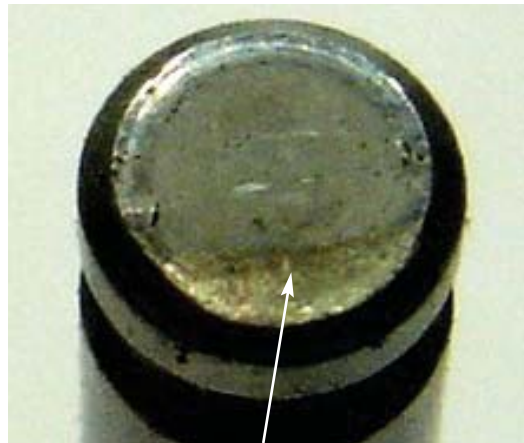
*Fig. 11.9.4 Marks indicating that the valve hasn't rotated. Rocker arm deficiency*
