PREMATURE FAILURES IN PISTONS

## Premature failures in pistons, piston rings, cylinder liners, bearings and bushings

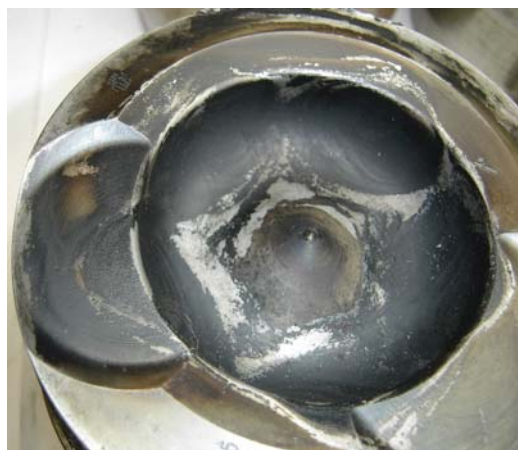
Fig. 2.6.3 Irregular spraying done by the nozzle

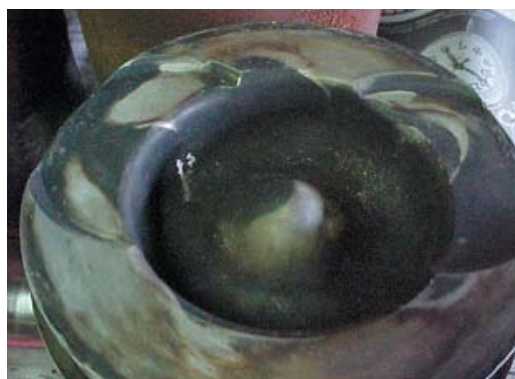
Fig. 2.6.4 Irregular spraying done by the nozzle

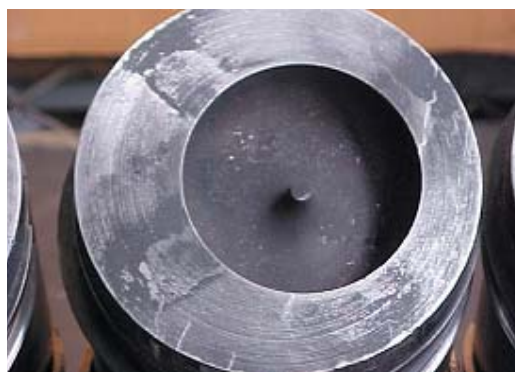
Fig. 2.6.5 Irregular spraying done by the nozzle

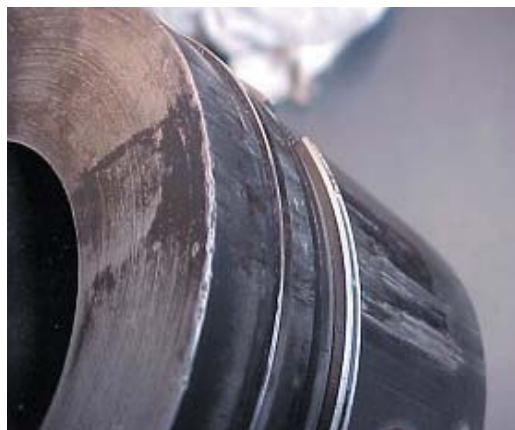
Fig. 2.6.6 Irregular spraying done by the nozzle

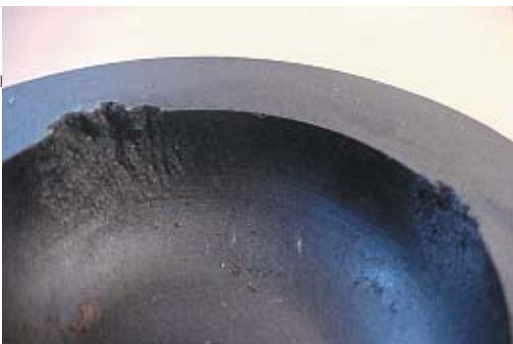
Fig. 2.7.1 Partial destruction of the combustion chamber

- Regulation of injection pump and nozzles, to achieve correct injection and spraying of diesel fuel;
- Correct fuel injection point.

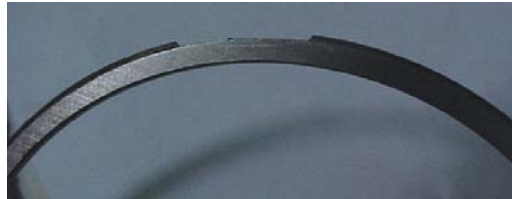
The tool used to close the piston rings when mounted on the piston, and being fitted in the cylinder, is a strap called "ring compressor". If the compressor doesn't close completely the piston rings in the groove, their side faces will collide with the cylinder edge (which should have a small chamfer to facilitate the mounting). This can result in damage or even breakage of the piston ring (see fig.3.4.2).

Fig. 3.4.2 Chipped contact face

- Don't use your hands when opening the gap ends;
- Mount the rings using adequate tools and in good working conditions, mainly the expander ring pliers;
- Use adequate ring compressor for each engine, when fitting the piston/piston ring assembly into the cylinder.

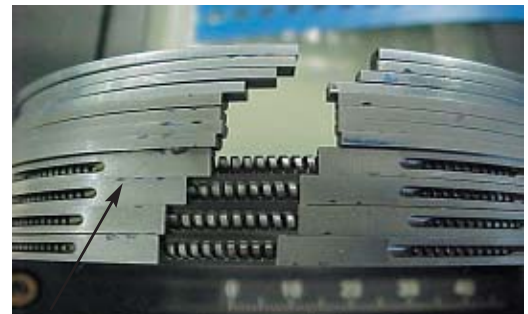
- The piston rings present scratches and premature wear at the running face (fig.3.5.1, 3.5.2, 3.5.3, 3.5.6 and 3.5.7), as well as on side faces (fig.3.5.4 and 3.5.5). The oil rings present a large and plain running face (in some cases even inexistent).

- Solid particles of different sizes are present in the air. These particles, such as sand (silica), dust, carbon, among others, when aspirated by the engine, cause serious damage to the piston rings, resulting in: premature wear of the coating on the running and side faces, reduction in radial thickness, increase in gap clearance, pressure reduction and deep scratches on the cylinders and on the piston skirt.

Fig. 3.5.7 Considerable wear on the third groove

- Use only filters according to the recommended applications, verify them and change them according to recommendations given by the engine/vehicle manufacturer;
- Make a periodical check-up of the filter system (hoses, clamps, seals, etc);
- Prepare and clean correctly the internal components before assembling them on the engine;
- Use fuel of good quality, as well as correct filter elements and separation filters.

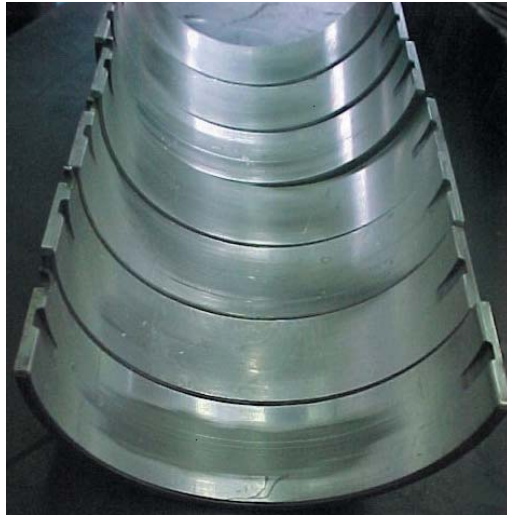
Fig. 8.10.3 Irregular bearings marks

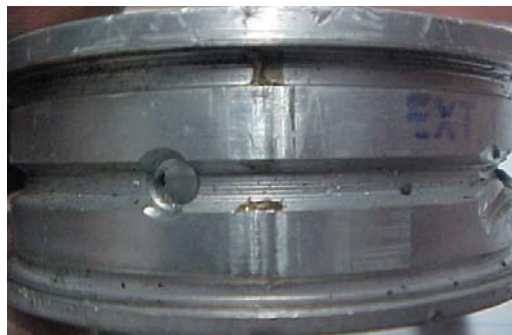
Fig. 8.13 Glue/adhesive on bearing's external lubrication channel

- The torque applied to the engine block studs/bolts, when exceeding the specification given by the engine manufacturer, tends to deformations and consequently to metal-metal contact. This contact generates sufficient heat to start the fusion and dragging of materials. Another factor leaving to fusion will be found in the partial obstruction of the external lubrication channels (fig.8.13) by glue/adhesive.

- Check/revise the wrench periodically;
- Apply the torque recommended by the engine manufacturer;
- Assemble the engine according to recommendations given by the engine manufacturer, specifically with regard to the use or no-use of glue/adhesive.

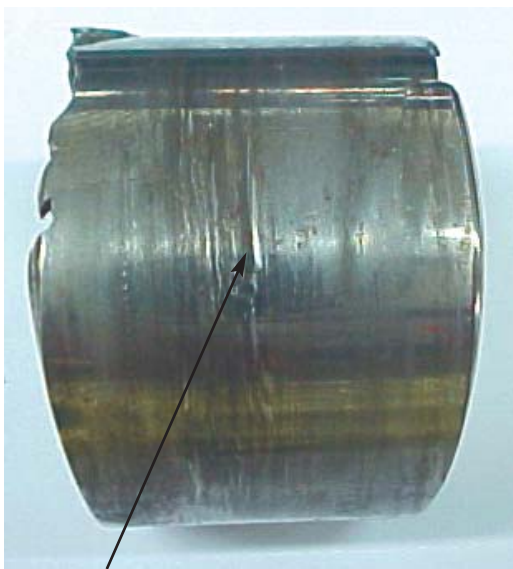
Fig. 10.3.1 Incorrect bushing mounting mark

- Use adequate tools for bushing mounting in the housing;
- Don't use deformed pieces.

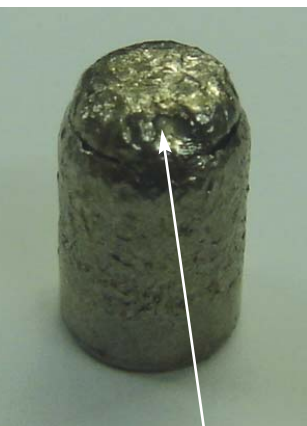
- During the valve replacement not only the springs shall be inspected and tested, as formerly informed, but also the keepers. Irregular and damaged keepers can be considered as causes of this type of failure, as well as excessive clearance during adjustment of the valves and also valve floating (fig.11.4.1, 11.4.2, 11.4.3, 11.4.4).

Fig. 11.4.1 Breakage at the keeper groove region

- Replace keepers and test the valve springs, as well as adjust correctly the valve clearance.

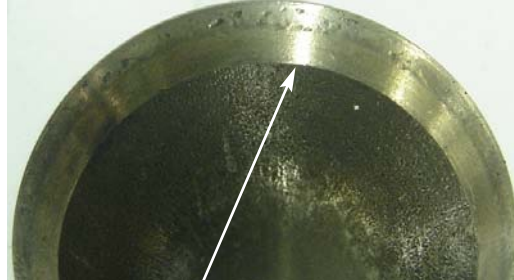
Fig. 11.7.2 Wear at the valve head region

- Wear is related to the increase in valve closing forces, combined with high operational temperatures and combustion pressures. Pre-ignition, detonation, poor fuel mixture and inadequate compression ratio are factors that affect and wear the valve head (fig. 11.7.1. and 11.7.2).
