PREMATURE FAILURES IN PISTONS

## Premature failures in pistons, piston rings, cylinder liners, bearings and bushings

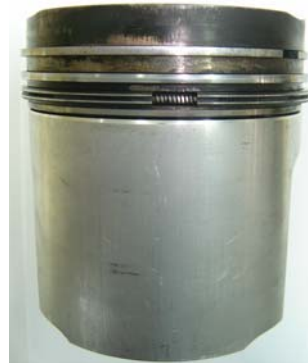
*Piston with normal running characteristics*

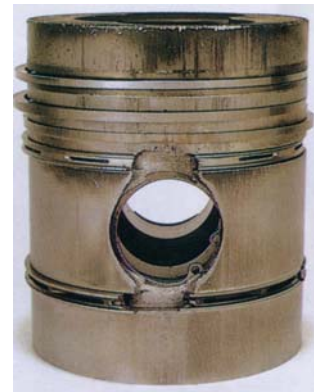
*Fig. 1.1*

- Breakage of the piston pin circlip groove. Generally this occurs due to a composition of forces that pushes the pin against one of the circlips, until its expulsion and/or fracture. Eventually pieces of the fractured circlip cross the inner pin diameter and damage the other end.

- Correct alignment of the con rods (changing them, if necessary);
- Cylinder rectification correctly aligned with the crankshaft;
- Correct circlip mounting, without deformations during assembly;
- Correct rectification of crankshaft journal;
- Check axial crankshaft clearance.

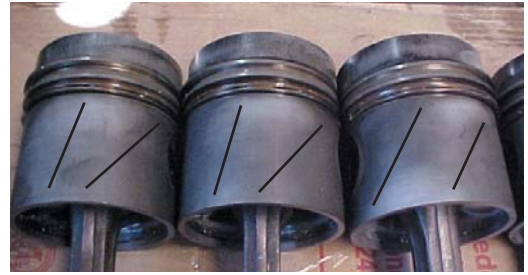
Fig. 1.3.1 Inclined marks at the piston skirt region

- Get a correct con rod alignment (changing them, if necessary);
- Rectification the cylinder, keeping it correctly aligned with the crankshaft;
- Small end bushing ID boring.

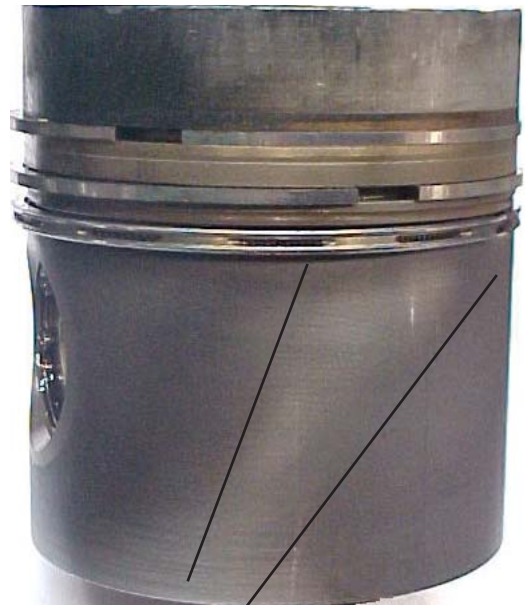
Fig. 1.3.3 Inclined marks

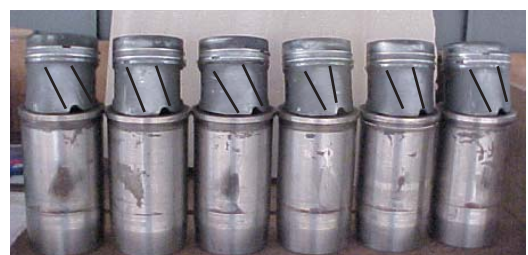
Fig. 1.3.4 Inclined marks at the piston skirt region

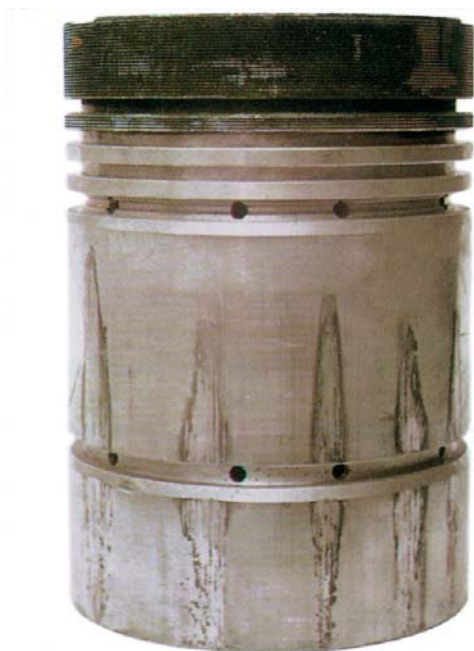
Fig. 1.4

Deformation of cylinder liners, caused by:

- Irregular engine assembly;
- Expanded o'ring seals during engine operation;
- Housing diameter of o'ring seals out of specification;
- Inadequate torque of cylinder head bolt;
- Deficient cylinder rectification.

- Provide correct machining of engine block bores for cylinder liner installation;
- Use o'ring seals of good quality;
- Verify o'ring seal housing dimensions;
- Give correct torque to cylinder head bolts.

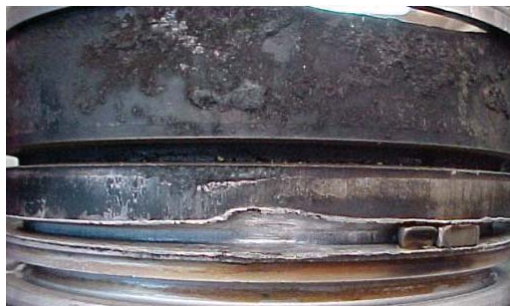
Fig. 1.5.1

Thus the piston has its resistance diminished, which can originate cracks that happen normally at ring lands.

The overheating of this piston region, plus the abrasion caused by the carbon materials, do result in excessive groove wear, and consequently could cause ring flutter.

- During ring changes, the groove conditions should be carefully checked, mainly the first ones, which run the compression rings;
- Keep the clearance between the rings and the grooves within the specified values.

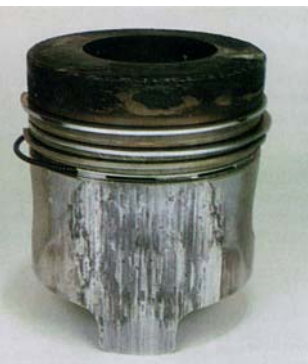
Fig. 1.6

- Considerable and generalized scuffing of the piston skirt, mainly at the thrust side, as a consequence of abnormal running, caused by a reduction of the clearance to values smaller than the ones specific in the project.

- Observe the piston/cylinder clearance recommended by the engine manufacturer.

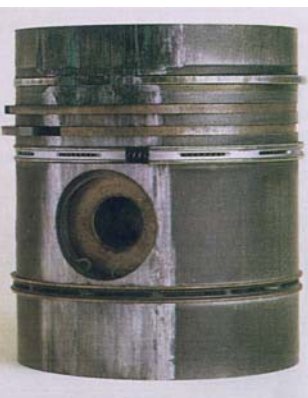
Fig. 2.1

- Excessive deposits in the engine block's water conduits, which have not been removed during the last reconditioning. These deposits cause considerable increase to the thermal resistance of the walls, increasing the piston temperature;
- The malfunction of the thermostatic valve, even during short periods, can lead to flow interruptions of the refrigerating water to the radiator, increasing therefore the engine temperature;
- Radiator in bad conditions, especially when internally or externally blocked. The thermal insulation of the radiator core from the exterior is a consequence of excessive deposits, mainly mud, at its external surface;
- A mechanical failure of the water pump can result in insufficient cooling water circulation, which is noted mainly when the engine runs at high power;
- A slack fan belt (slipping in excess),

- A faulty radiator cap doesn't offer sufficient water-sealing, and causes the fall in water pressure and frequent water "boiling";
- Draining the cooling system to remove possible air bubbles, when filling the system with additivated water.

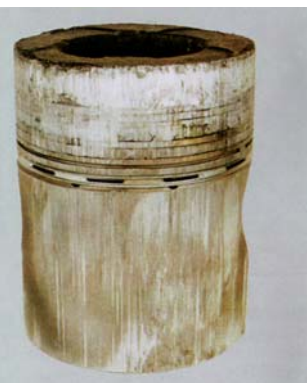
Fig. 2.6

- Scuffing stripes from piston crown downwards, generally in the direction of the diesel oil injection, tending to expand later to other regions.

- The dilution of the lubricating oil film, existing on the cylinder walls, happens due to fuel injected in excess. This can be the case when the fuel pump inject more fuel than specified and/or when there is an incorrect spraying done by the nozzles.

The oil film dilution generates a metal-metal contact between the piston and the cylinder. The temperature raises substantially due to friction and the piston expands excessively, until it gets scuffed.

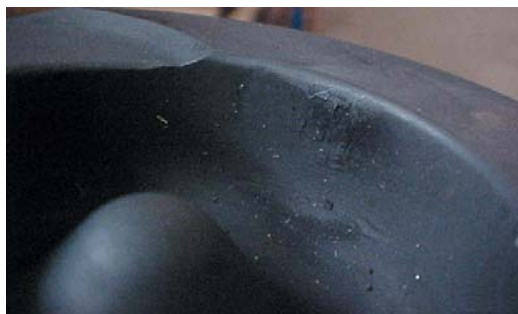
Fig. 2.6.1 Spraying occurs partially out of the combustion chamber

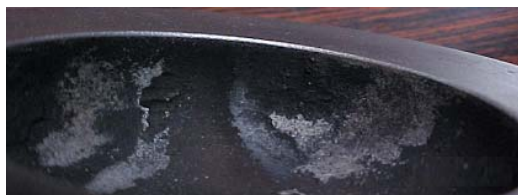
Fig. 2.6.2 Spraying occurs partially out of the combustion chamber

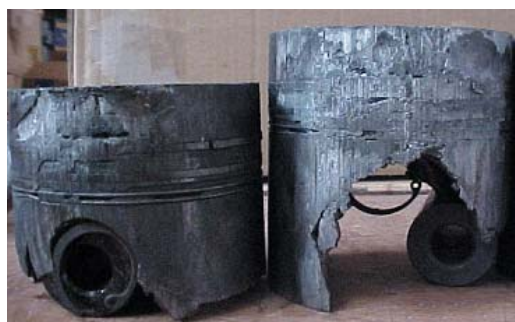
Fig. 2.6.7 Scuffing started at the top land, followed by rupture at the pin boss

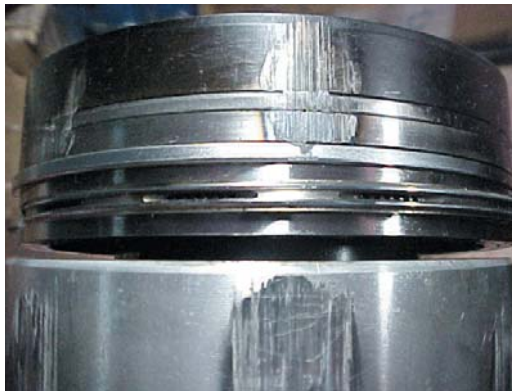
Fig. 2.7.3 Scuffing started at the top land, and extended to the piston skirt

- Regulation of injection pump and nozzles, to achieve correct injection and spraying of diesel fuel;
- Correct fuel injection point.

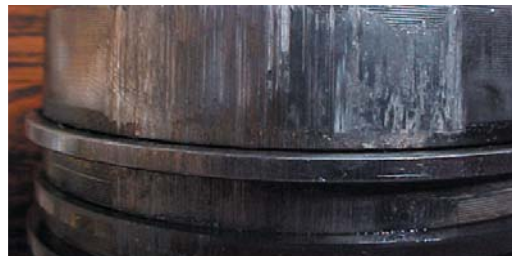
Fig. 2.7.4 Scuffing started at the top land

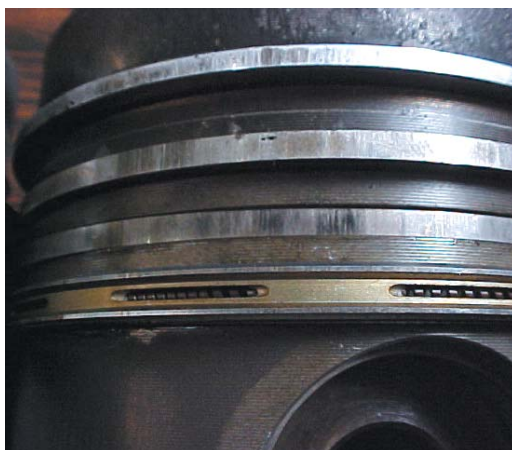
Fig. 2.7.5 Scuffing started at the top land

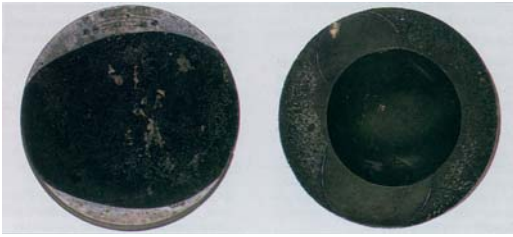
Fig. 2.8

- Piston stroke increase, due to loosening of a con rod bolt;
- The carbon deposits formed at the piston crown are thicker than the top clearance, resulting in piston impacts on the cylinder head;
- Engine block height below specifications;
- Change in piston stroke due to incorrect grinding of crankshaft journal;
- Change in length of con rod;
- Reduction of cylinder head height, without the corresponding adjustment of depth of valve seats;
- Valve floating;
- Incorrect synchronization of camshaft.

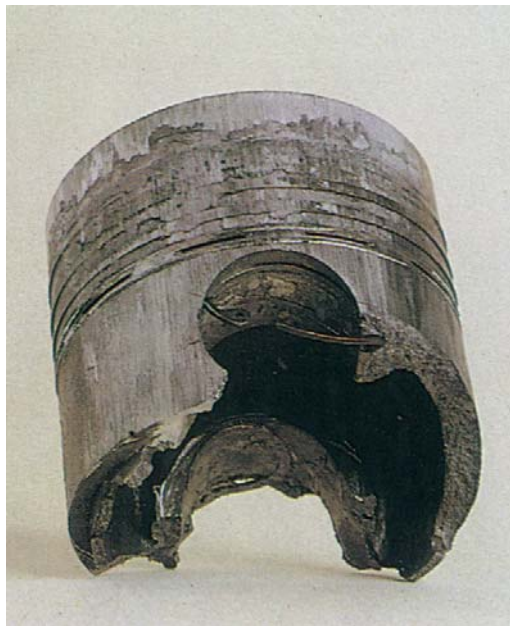
Fig. 2.9

- Incorrect clearance when fitting piston/cylinders;
- Engine overload during running-in period;
- Insufficient cooling;
- Insufficient lubrication;
- Abnormal combustion.

When the scuffed piston is moved-on by the other ones, its skirt is torn out, starting at the middle section of the pin bore.

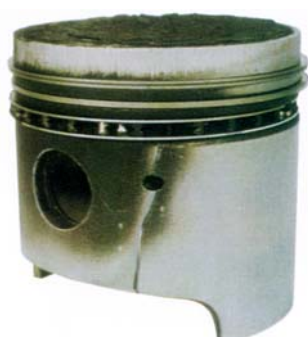
Fig. 2.11

This type of crack is characteristic in cases of engine overload and, consequently, overload of the piston. Generally it occurs at the high-pressure side (thrust side), because the most loaded region is the skirt, which in this case is submitted to excessive flexion.

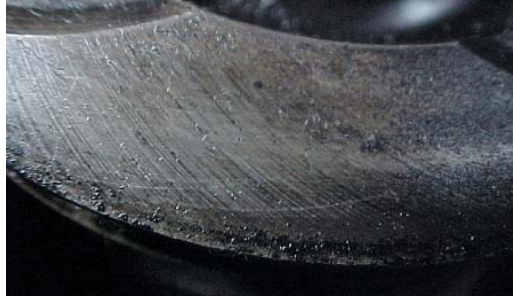
- The machining of the piston crown reduces the distance between the first ring groove and the crown (top land height reduction). This reduction, plus the withdrawal of the concordance of the combustion chamber edges radii, results in an increase in piston crown tensions, increase in concentration of tensions at said combustion bowl rim and, consequently, increase in susceptibility for cracks in this region (see fig. 2.13.6).

Fig. 2.13 Machined crown

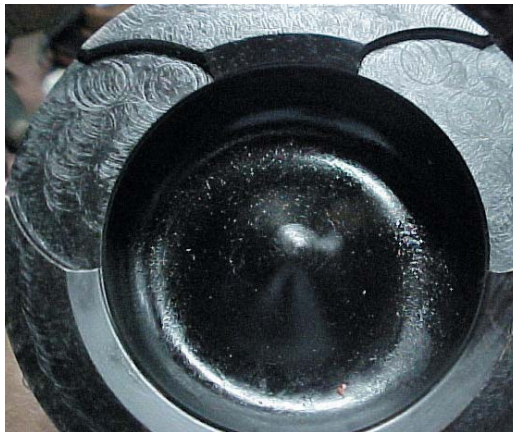
Fig. 2.13.2 Machining marks on piston crown and valve recesses

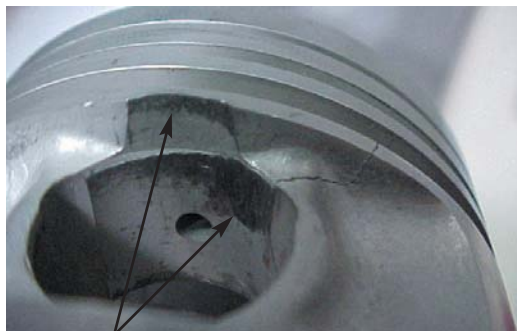
- The part presents irregular marks on the piston pin, as a result of overheating. The piston also can present: cracks/fractures at the pin boss region, lubricating oil consumption, aligned ring end gaps and noises.

Fig. 2.14.2 Irregular piston pin marks on the bosses during con rod fitting

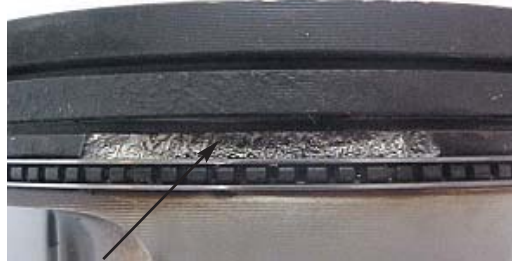
- Diesel and Otto-cycle pistons present rupture/breakage at first and/or second land between ring grooves.

a consequence of a sudden combustion pressure peak. This occurs due to the an increase in admitted fuel volume/mass, due to the decrease in combustion chamber volume in the cylinder head and also due to an incorrect injection/ignition point. Under these conditions the piston is submitted to an increase in mechanical and thermal loads (higher peak pressure), causing the rupture of the lands between the ring grooves. This rupture/ breakage is related to the process called "DETONATION".

Fig. 2.15.1 Broken land in piston (Otto-cycle engine)

- Keep the cylinder head height according to recommendations given by the engine manufacturer;
- Keep the engine block height according to the recommendations given by the engine manufacturer;
- Keep the projection of the piston in relation to the engine block according to the recommendations given by the engine manufacturer;
- Don't use fuel of bad quality;
- Revise peripheral engine component (injection pump and nozzles, cold start system, starting motor and battery);
- Use heating spark plug correctly (if existent);
- Apply the parts and the components correctly;
- Use correct injection point;
- Check items which could lead to "DETONATION".

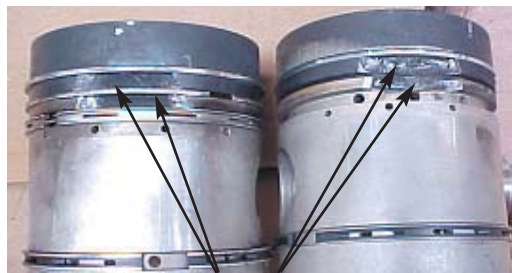
Fig. 2.15.3 Fractured lands in piston (Diesel-cycle engine)

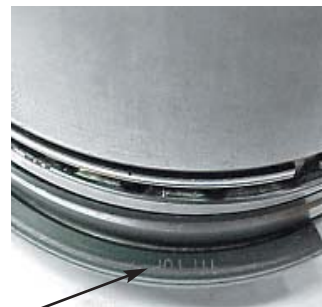
- Wrong/inverted mounting of the piston rings in the piston grooves (fig.3.1 and 3.1.1). When this happens, the piston rings don't perform as expected, allowing the combustion chamber gases to leak easily to the carter, forming consequently an irregular air/fuel mixture to be admitted to the combustion chamber. The lubricating oil temperature and the carter pressure increase. Furthermore the inverted mounting of the piston rings increases the lubricating oil consumption, because instead of scraping the oil down, the piston rings will pump it up, to be burnt together with the air/fuel mixture

Fig. 3.1.1 Piston ring mark mounted towards the lower side

- Replace the ring set and fit the new one with its markings directed to the piston crown.

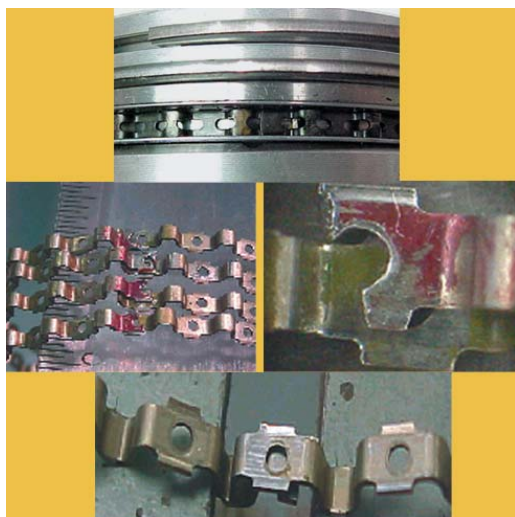
Fig. 3.2.1

- The mounting of overlapped coil spring (fig.3.2) or expander (fig.3.2.1) ends during the oil ring assembly affects the radial piston ring pressure, and consequently its function, which is to control the excess in lubricating oil of the cylinder walls. This radial pressure reduction will result in a considerable increase in oil consumption.

- The spring-ends of a 2-piece oil ring have to be mounted at 180° from the gap. The overlapping of the expander ends in a 3-piece oil ring should by all means be avoided.

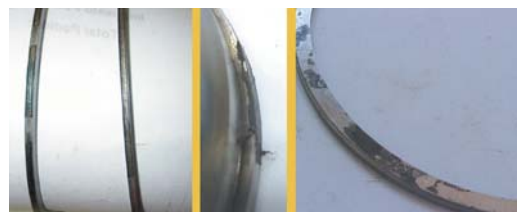
Fig. 3.3

impregnated at its running and side surfaces (fig.3.3).

- The piston ring contamination by odd material occurred during the engine assembly. The use of adhesives for engine sealing, close to the cylinders, is a procedure which no manufacturer/producer recommends. In this case the contaminated piston rings had its sealing function reduced, because the pressure at the periphery has been unevenly distributed, due to the "wedge" provided by the adhesive. This reduces the operational life of the piston rings, causing an increase in lubricating oil consumption and irregular wear at the cylinders.

- Mounting has to be done according to recommendations given by the engine manufacturer;
- Clean all internal components with materials void of dirt and impurities, by using the adequate procedure.

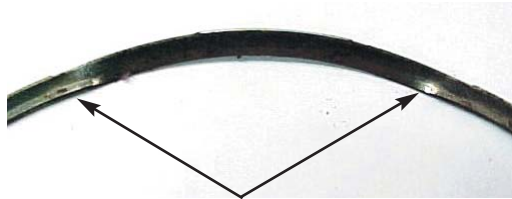
- The piston ring is twisted (with displaced butts) and deformed (fig. 3.4.1 to 3.4.2).

localized pressure against the lateral piston groove faces, wearing these areas, on top of reducing the lateral sealing. Due to these conditions the piston rings will not rotate in the groove, starting irregular wear at its running face and at the cylinder walls, increasing the oil consumption and the blow-by (flow of combustion gases to the carter).

Fig. 3.4.1 Ring was twisted during mounting

- Don't use your hands when opening the gap ends;
- Mount the rings using adequate tools and in good working conditions, mainly the expander ring pliers;
- Use adequate ring compressor for each engine, when fitting the piston/piston ring assembly into the cylinder.

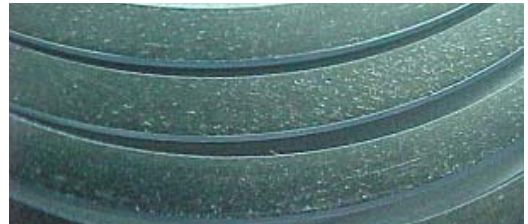
- The piston rings present scratches and premature wear at the running face (fig.3.5.1, 3.5.2, 3.5.3, 3.5.6 and 3.5.7), as well as on side faces (fig.3.5.4 and 3.5.5). The oil rings present a large and plain running face (in some cases even inexistent).

- Solid particles of different sizes are present in the air. These particles, such as sand (silica), dust, carbon, among others, when aspirated by the engine, cause serious damage to the piston rings, resulting in: premature wear of the coating on the running and side faces, reduction in radial thickness, increase in gap clearance, pressure reduction and deep scratches on the cylinders and on the piston skirt.

Fig. 3.5.5 Piston ring with abrasive particles on lateral face

- Use only filters according to the recommended applications, verify them and change them according to recommendations given by the engine/vehicle manufacturer;
- Make a periodical check-up of the filter system (hoses, clamps, seals, etc);
- Prepare and clean correctly the internal components before assembling them on the engine;
- Use fuel of good quality, as well as correct filter elements and separation filters.

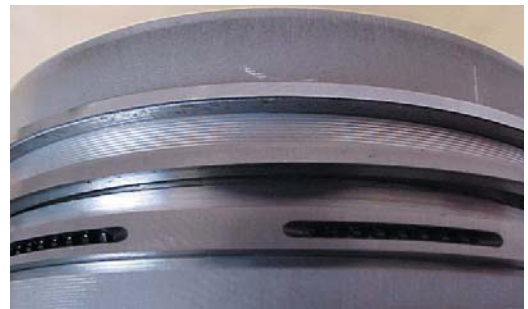
Fig. 3.5.6 Worn-out piston ring of the third groove

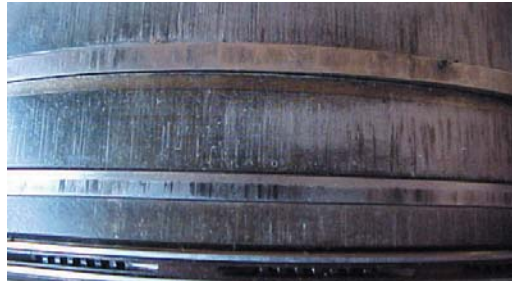
Fig. 3.6.1

- The rings present scuffing signals on the running surface (fig.3.6.1 to 3.6.5).

- **Injection system and/or carburetion deficiencies** - the main causes for the cylinder washing are connected to an incorrect regulation of the injection pump and nozzles, resulting in a series of changes: quantity of delivered diesel fuel, injection-pump rotation, synchronization between governor and pump, synchronization among pump elements, opening pressure and projection of the injection nozzles out of recommendation, and the height of the piston crown, in case of Diesel-cycle engines. For the Otto-cycle engines the "big villain" is the carburetor with bad application and/or regulation. All of this will wash the lubricating oil from the cylinder walls. Both the Diesel and the Otto-cycle engines, in presence of insufficient oil lubrication of the cylinders, will increase the friction and the heating of the piston rings, which can result in flaking-off (fig.3.6.5) and can initiate a scuffing process, seizing of the cylinders, or also can wear the cylinders in excess;

- **Lubricating system deficiencies** - a worn-out lubricating oil pump will reduce its pumping capacity, having as a consequence, the reduction in pressure in the oil circuit, and jeopardizing the engine lubrication, originating in this way the above-mentioned damages.

- Keep the injection system and the carburetor always regulated, following the recommendations given by the manufacturer/producer;
- Check periodically the engine oil lubricating system;
- Check and maintain the original turbine.

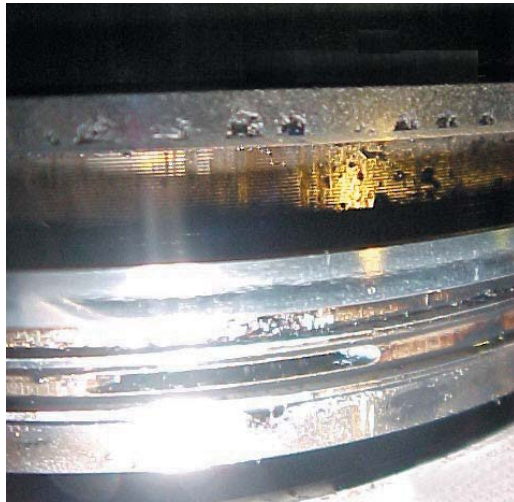
Fig. 3.6.5 Flaking-off of the piston ring coating

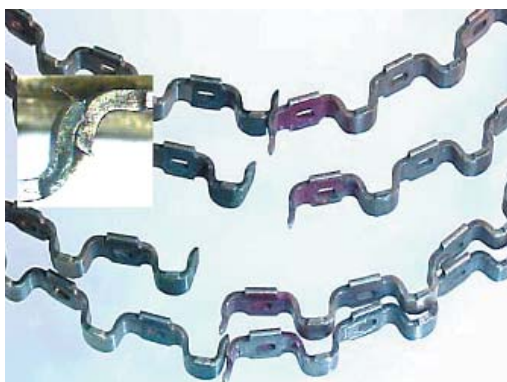
- The reworking of the piston ring butt ends is done to reduce its external diameters and to adapt them for different applications than the ones for which they have been recommended by the engine manufacturer. The change in the constructive characteristics of piston rings is not recommended by MAHLE and cancels any product warranty.

Fig. 3.7.2.8 Adulteration on one of the ends

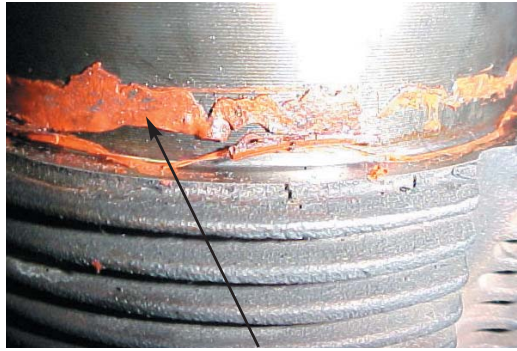
The use of glue/adhesive, after it dries, causes uncontrolled deformations on the cylinder liner walls, and can reduce its operational life. The consequences can be:

Fig. 4.1.2 Silicone at the lower base of the cylinder liner

- Follow correctly the recommendations given by the engine manufacturer with respect of the use or no-use of glue/adhesives.

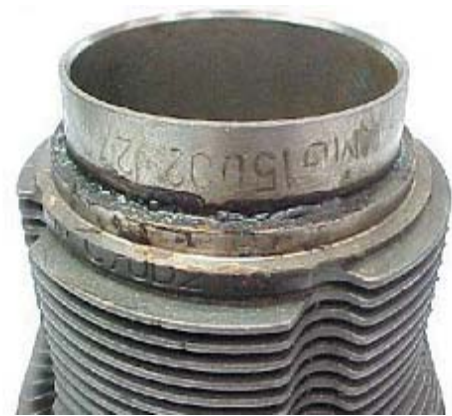
Fig. 4.1.4 Cylinder head was fitted with glue at its lower base

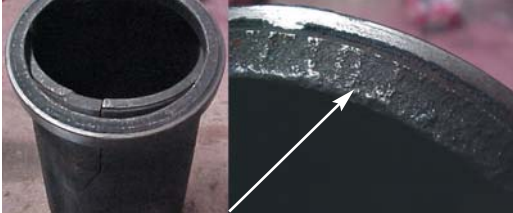
- Flange fracture of the cylinder liner and/or insufficient sealing with the cylinder head.

fastening to the engine block. In engines using dry cylinder liners, if the applied tensions happen to be higher than the ones recommended by the engine manufacturer, a flange fracture could also occur.

Figs. 5.1 and 5.1.1 Wet cylinder liner. Fractured and carbonized flange region

- Keep the dimensions of the cylinder liner seat at the engine block according to recommendations given by the manufacturer/producer;
- Follow the engine manufacturer recommendations when fitting the cylinder liners at the engine block;
- Machine correctly the cylinder liner seat at the engine block;

- Lower the cylinder head without lowering the cylinder liner housing seat depth at the head (for example: the VOLVO TD-102 FS cylinder head).

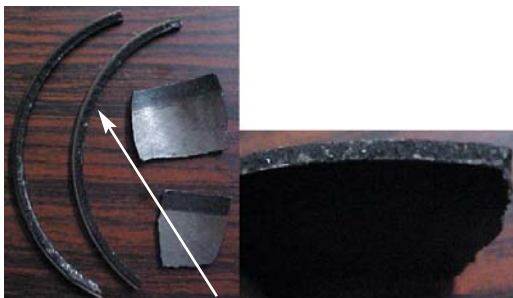
Figs. 5.1.2 and 5.1.3 Dry cylinder liner. Carbonized flange region

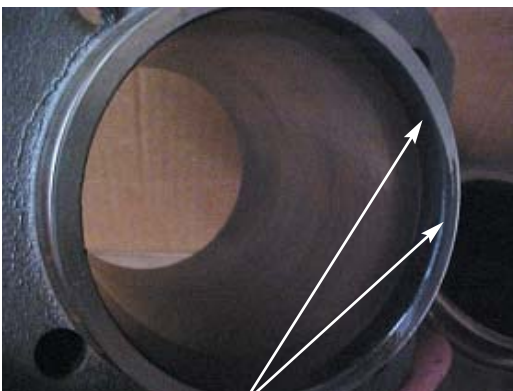
Fig. 5.1.5 Irregular seat between the upper cylinder liner part and the cylinder head

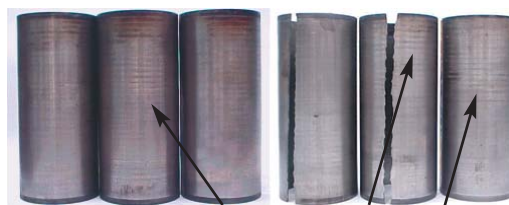
In engines running with **wet cylinder liners**, irregularities on the engine block housing, O'rings and even the displacement of these rings during the fitting of the cylinder liner, can cause:

- Change in clearance between the piston and the cylinder liner, due to deformations, with possible scuffing originated by the displacement of material from the piston skirt region, at the area where the O-rings are installed in the engine block. Scuffing could expand later to the piston ring region. If necessary, remove the cylinder liner and re-install it, eliminating excessive deformations.

Fig. 5.2 cylinder liners with machining marks from engine block

- After installation of the wet cylinder liner in its housing, measure the internal diameter with specific instruments and search for any cylinder liner deformation.

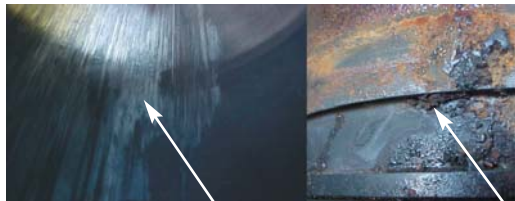
Figs. 5.2.2 and 5.2.3 Scuffing originated by O'ring displacement. Impurities in the cylinder liner O'ring housing

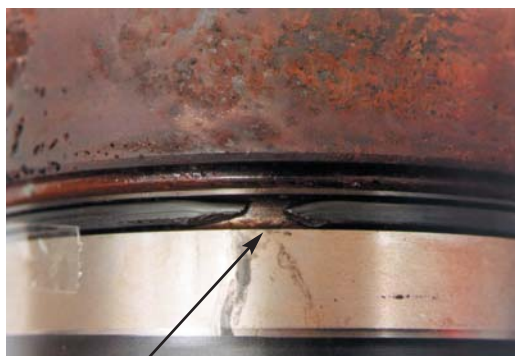
Fig. 5.2.4 O'ring has been cut during cylinder liner fitting in engine block

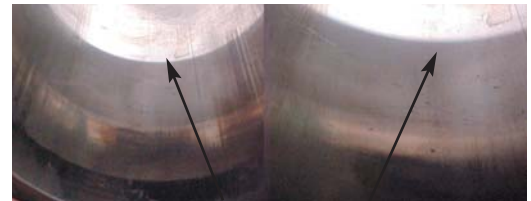
- The dilution of the lubricating oil of the inner cylinder liner wall results in a premature lapping wear done by the piston rings, and generates vertical scratches and scuffing marks, with material removal.

- Incorrect injection pump and nozzle regulation;
- Turbo charger ;
- Incorrect projection of the injection nozzles, in relation to the cylinder head;
- Incorrect injection/ignition points;
- Bent camshaft or with defect cams;
- Incorrect carburetor regulation;
- Incorrect engine running-in period.

Fig. 5.3 Cylinder liner with bore polishing, due to constant speed

- Regulate injection pump and nozzles, according to recommendations given by the engine manufacturer;
- Keep the correct injection point;
- Check the camshaft and its cams;
- Regulate correctly the carburetor;
- Apply correctly the internal components (pistons, cylinder liners and piston rings);
- Avoid constant engine speed during the running-in period.

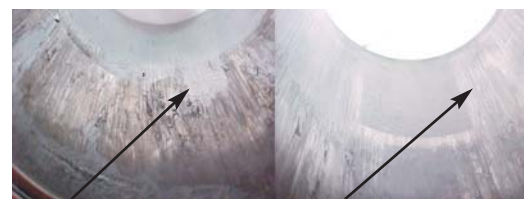
Figs. 5.3.1 and 5.3.2 Scuffing originated by dilution of lubricating oil existent on inner cylinder wall

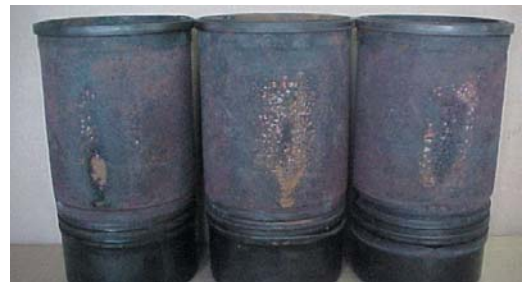
Fig. 6.1.5 Cavitation

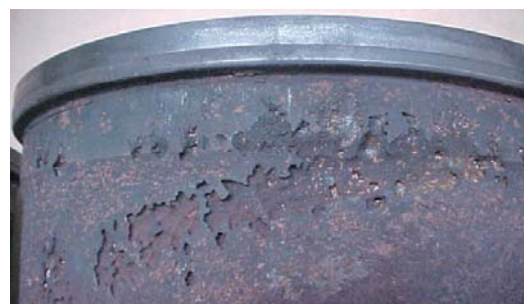
Fig. 6.1.6 Cavitation

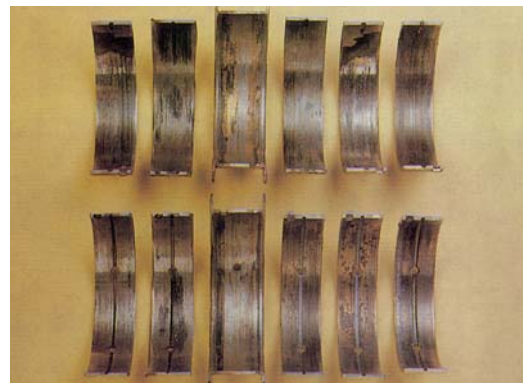
Fig. 7.2.1

higher than the lead (326°C) or tin (231°C) fusion temperatures, and is subjected to considerable dragging forces by the shaft, the anti-friction material reaches a point of fragility by heat. Under these conditions, the lead or tin can move, separating itself from the copper, and the surface layer loses its adhesion with the steel shell, resulting consequently in material detachment. The fragility by heat condition is a consequence of excessive heat increase in some bearing zones. The excessive heat can be the result of insufficient radial clearance, impurities, crankshaft journal deformation, or misalignment of the engine block and/or the crankshaft.

- Fit the bearings with the clearance recommended by the engine manufacturer;
- When changing lubricating oil, observe absolute cleanliness and when assembling the engine, eliminate all machining residues and any existing dirt;
- Before fitting new bearings, inspect carefully all journal dimensions of the crankshaft;
- Verify the alignment between engine block and crankshaft.

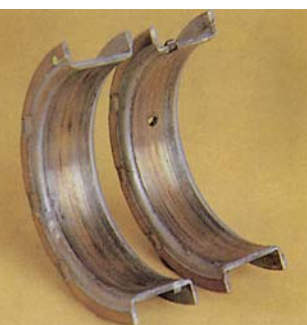
Fig. 7.2

- When a running bearing heats up to values

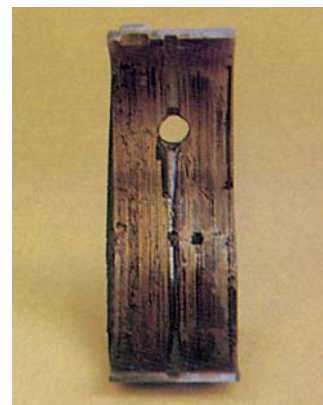
Fig. 7.4

- When a bearing fails because of insufficient or diluted lubricating oil, its running surface can get shiny (fig. 7.4.2). In the case of complete lack of lubrication, the bearing will present excessive wear by dragging off material along the axle, at the contact zone of the bearing sliding surface, with the journals of the crankshaft.

Insufficient or diluted lubricating oil film between the bearing and the axle, will wear the electrodeposited layer. It is normally caused by:

- Check the oil pump and relieve valve's running conditions. Recondition or change them, if necessary;
- Check if the bearing oil holes are in-line with the corresponding holes on the engine block and con rods;
- Avoid engine running at low speed for long periods;
- Check de dilution of lubricating oil by the fuel or the cooling liquid.

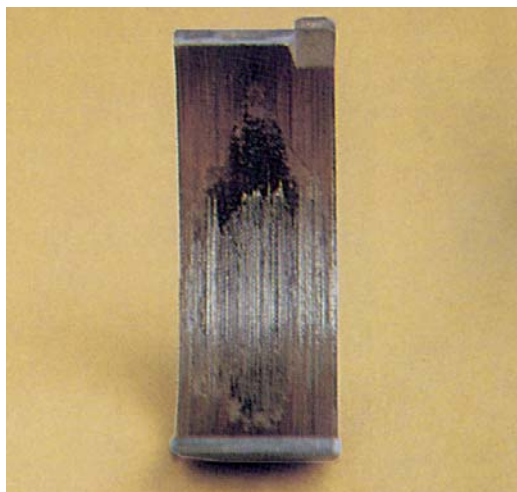
Fig. 7.4.1

The lack of lubricating oil leads to metal-metal contact between the bearing and the crankshaft journal, and to excessive wear, due to dragging away of anti-friction material. It is normally caused by:

- Partially clogged oil galleries;
- Incorrect choice of bearing under-size;
- Inverted mounting of the main bearings (lower part versus upper part);
- Bad functioning of the oil pump or the relieve valve.

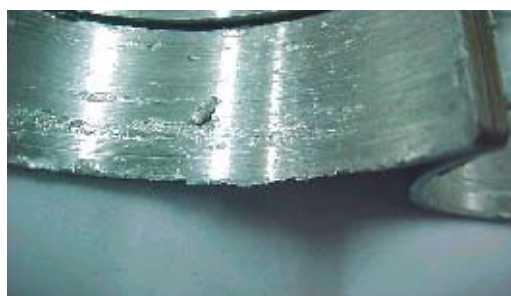
dynamic support to the axle. This results in a contact between the axle and the bearing surface, causing fusion and surface deformation of the bearing's anti-friction alloy (figs. 7.6 to 7.6.3).

Fig. 7.6.2 Yield of material

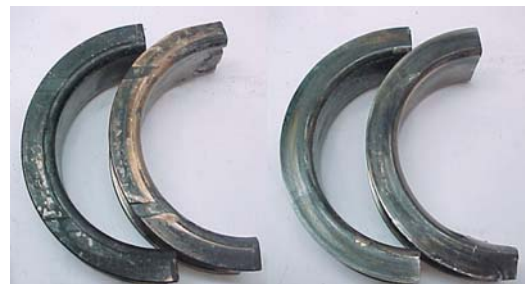
Fig. 8.1.3 Bearing flange front side without wear and back side with wear

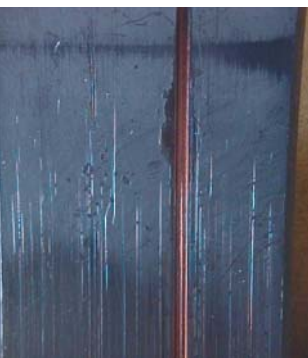
Fig. 8.2.5 Enlarged photo of a channel opened by an odd solid material, strange to the bearing

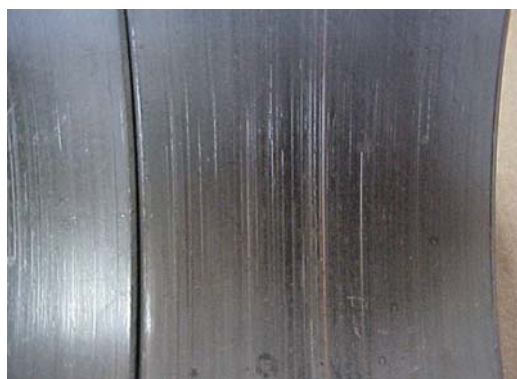
Fig. 8.2.6 Contaminated con rod bearing with circumferential scratches

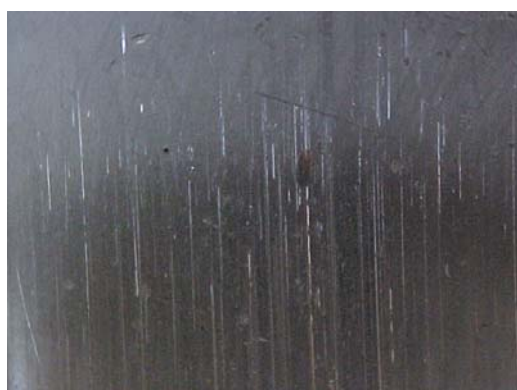
Fig. 8.2.7 Enlarged photo of scratches and odd materials on a bearing

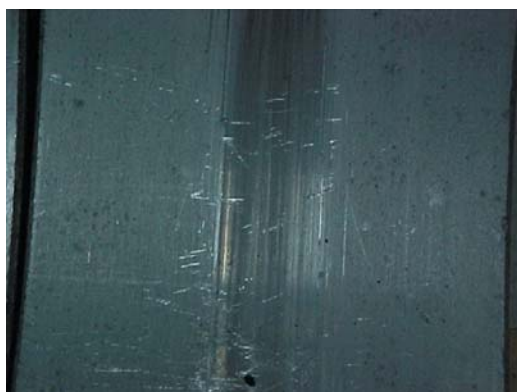
Fig. 8.2.8 Contaminated con rod bearing and circumferential scratches in the lubricating hole direction

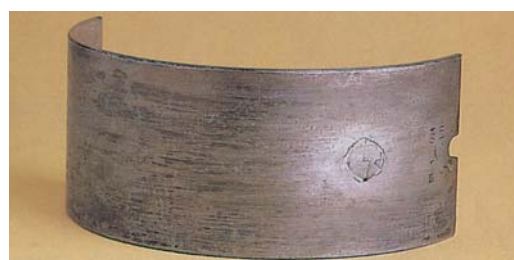
Fig. 8.3.1

- Localized worn areas at the alloy's surface, corresponding to a mark caused by the presence of odd particles at the bearing back.

- Clean carefully the housing, eliminating all burrs, dirt and solid particles, before installing new bearings;
- Check the crankshaft journal and grinding them, if necessary.

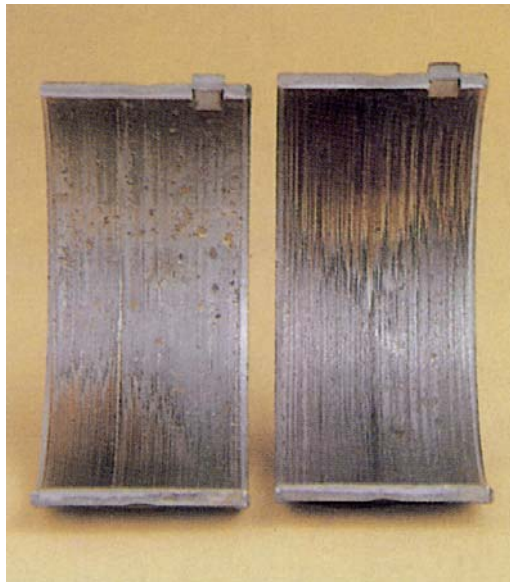
Fig. 8.8.1

- Areas with excessive wear on diagonally opposed sides of each bearing, close to the part line surface.

The bearing cap was displaced, forcing one side of each bearing against the camshaft (fig. 8.8). This can happen, due to following causes:

- Choose adequate wrench and fasten bolts alternatively in order to get a perfect cap seating;
- Be sure the cap position is correct;
- Check if the cap centralizing system is not altered nor damaged, and replace it, if necessary;
- Replace the con rod and/or housing bolts according to the recommendations given by the engine manufacturer;
- Machine the crankshaft according to specifications given by the engine manufacturer.

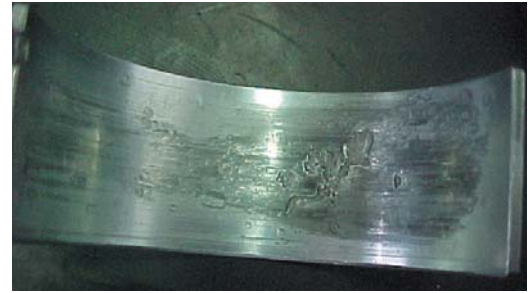
Fig. 8.8.3 Premature wear

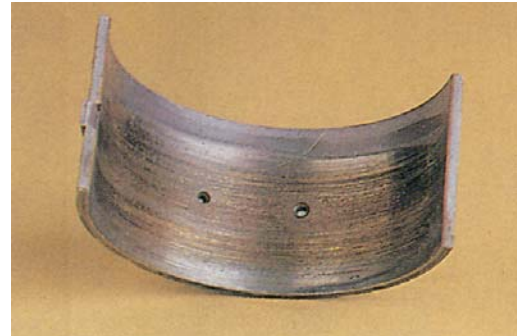
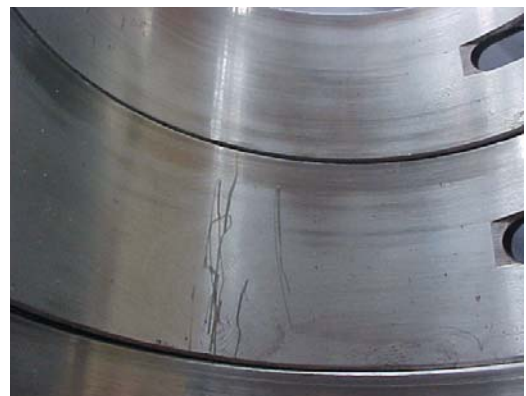
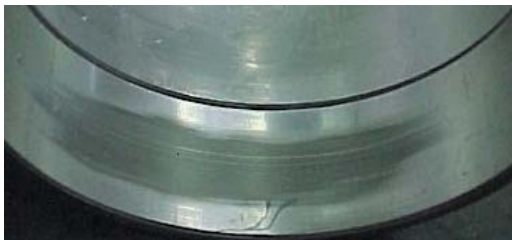
- Unequal wear strip on bearing. Depending on the regions where the highest pressures have been active, three main aspects can be distinguished, which correspond respectively to form defects of the illustrated crankshaft journal (fig. 8.11 - A, B and C).

- Non-cylindrical crankshaft journals impose an irregular load distribution over the bearing surface, generating higher heat levels in certain areas and accelerating wear. Clearances can result insufficient and metal-metal contact can then occur between the bearing and the crankshaft journals.

- Grind correctly the crankshaft journals and the housings.

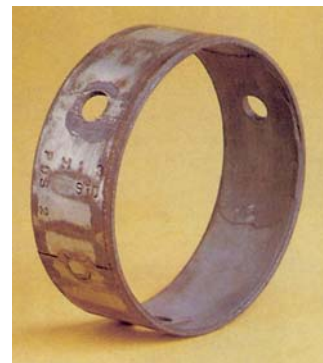
*Fig. 10.2*

Should the housing form tolerances not comply with the tolerances given by the engine

manufacturer, the contact area between the bushing and the housing will be reduced, resulting in a bad seating of the bushing. This doesn't allow a good dissipation of the heat generated by the bearing operation, and can result in a fusion of the bushing alloy. It can also result in a form error on the internal diameter, after the bushing has been fitted, interrupting the lubricating oil film and consequently causing fatigue, scuffing and material detachment.

- Check the housing circularity before mounting a new bushing;
- In the case of a highly deformed housing, rectify it and use bushings with external oversize;
- Keep the clearance and interference specifications between the bushing and the housing, as recommended by the engine manufacturer.

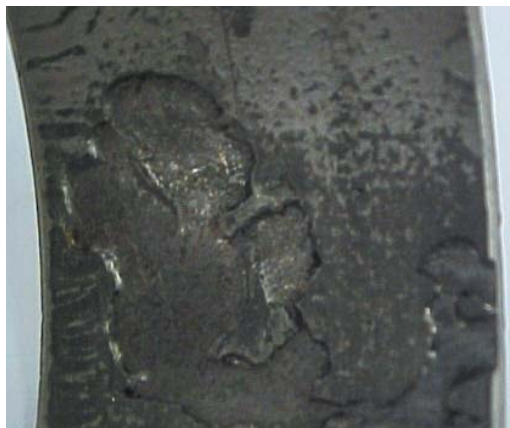
Fig. 10.2.1 Alloy detachment

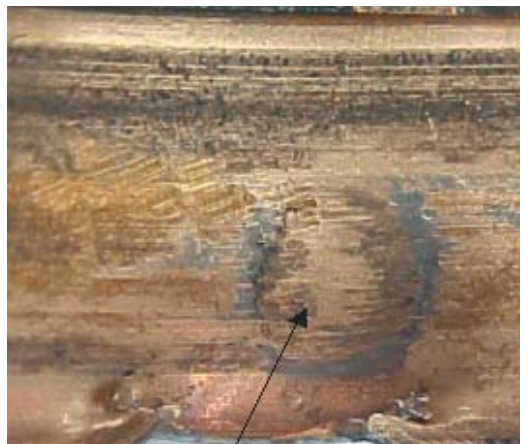
Fig. 10.2.5 Internal mark formed by odd material

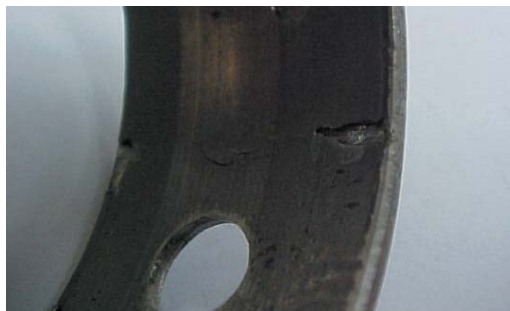
Fig. 10.2.2 Alloy detachment

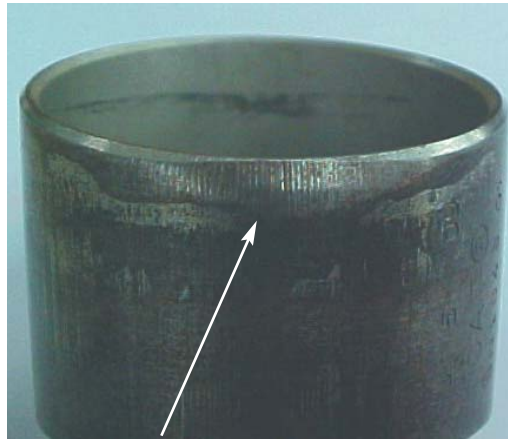
Fig. 10.3.2 Inclined bushing mounting mark

- Use adequate tools for bushing mounting in the housing;
- Don't use deformed pieces.

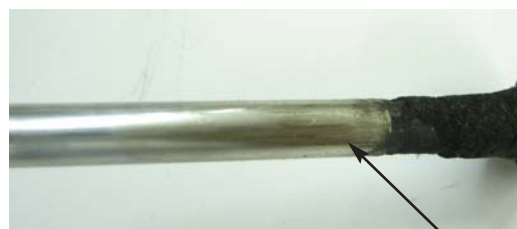
generated by the combustion of the mixture, when deposited on the lower part of the valve stem, can jeopardize the clearance between the stem/valve guide in this region and start the seizing (fig.11.1.4).

Fig. 11.1.4 Scuffing due to insufficient clearance between valve and valve guide

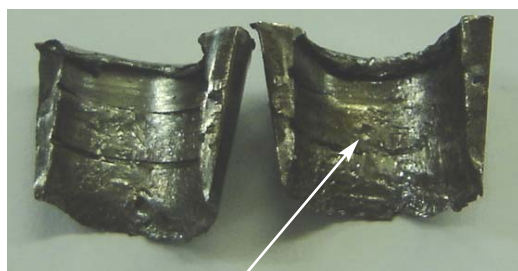
- During the valve replacement not only the springs shall be inspected and tested, as formerly informed, but also the keepers. Irregular and damaged keepers can be considered as causes of this type of failure, as well as excessive clearance during adjustment of the valves and also valve floating (fig.11.4.1, 11.4.2, 11.4.3, 11.4.4).

Fig. 11.4.2 Damaged keeper

- Replace keepers and test the valve springs, as well as adjust correctly the valve clearance.

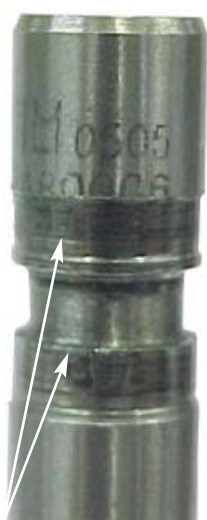
Fig. 11.4.4 Wear at the keeper groove channel caused by irregular keeper

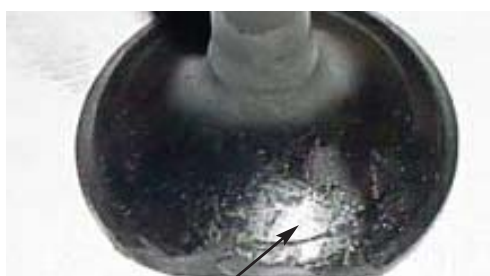
- The start of the fissure is given by a thermal shock caused by unequal heating, which results in thermal fatigue. Misalignment between valve steam and valve seat and insufficient contact (valve/valve seat) lead to inadequate cooling. The incorrect operation of the vehicle, as well as the use of uncoupling during descents (gear box in the neutral position) also contribute to thermal fatigue (fig. 11.5.1 and 11.5.2).

Fig. 11.5.1 Broken head

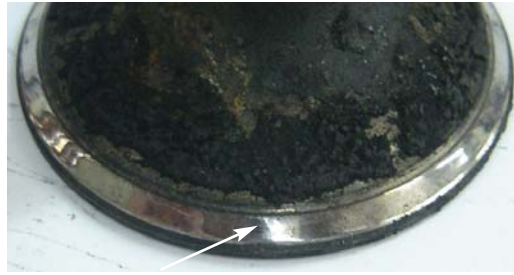
Fig. 11.7.1 Wear at the valve head region

- Wear is related to the increase in valve closing forces, combined with high operational temperatures and combustion pressures. Pre-ignition, detonation, poor fuel mixture and inadequate compression ratio are factors that affect and wear the valve head (fig. 11.7.1. and 11.7.2).

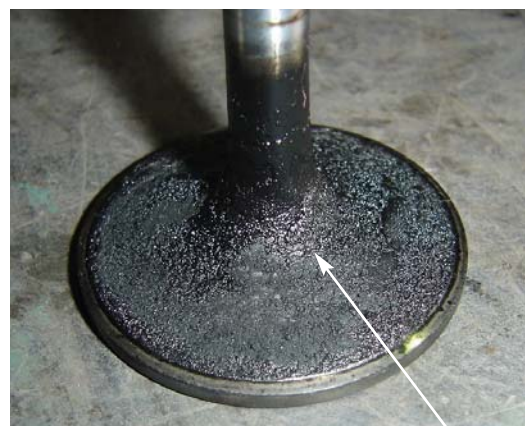
of the rocker arm over the valve, if taken in relation to the cylinder head valve seat axle. It should also be mentioned that the cylinder head seats should be rectified, taking angles and minutes into consideration. The different values between the valve seat and the cylinder head seat permit the valve to be bedded correctly during the cylinder combustion (fig.11.9.1; 11.9.2; 11.9.3; 11.9.4).

Fig. 11.9.2 Inlet valve contaminated by lubricating oil due to excessive clearance between valve and valve guide or malfunction of oil seal

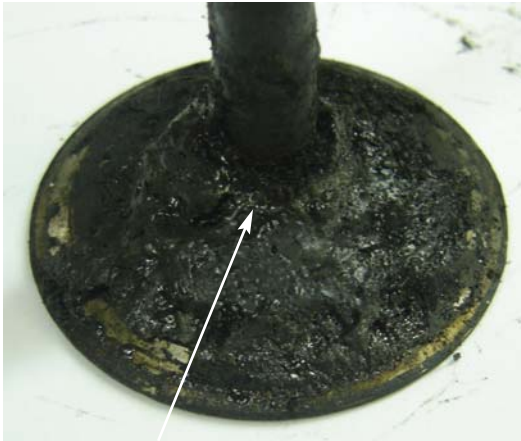
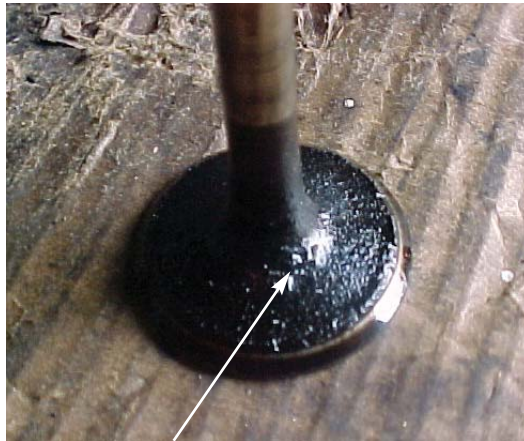
*Fig. 11.9.3 Contaminated inlet valve with lubricating oil crust due to excessive clearance between valve and valve guide or malfunction of oil seal*
